# Preliminary Site Investigation

555 Birchs Road,  
Lincoln

Prepared for:  
Prepared by:  
Date:  
Document No:

Urban Estates Limited  
Sephira Environmental Limited  
May 2024  
UEL-A0936-002R-v0

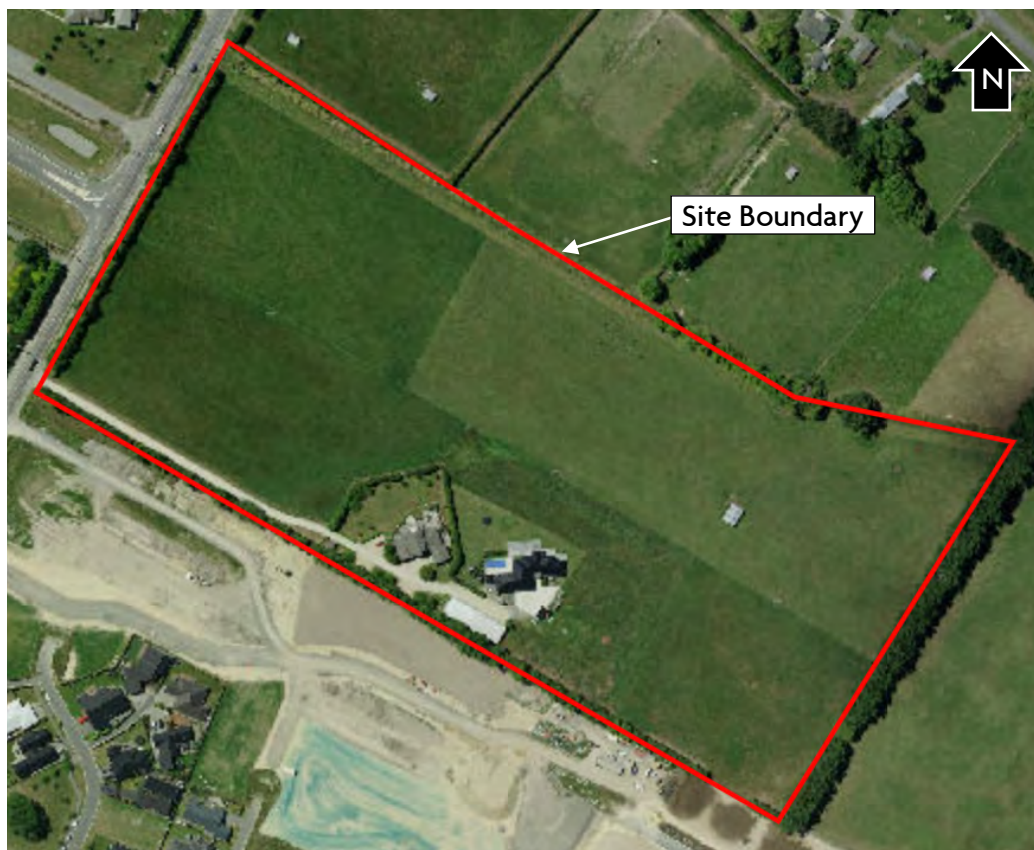
The site consists of five large, grassed paddocks, two dwellings, and two detached sheds. No other structures are located at the site. The site is bound by lifestyle blocks to the north and east, a residential development to the south, and Birchs Road to the west.

Figure 2: Recent Site Conditions (2020) (base image source: [mapviewer.canterburymaps.govt.nz](https://mapviewer.canterburymaps.govt.nz))

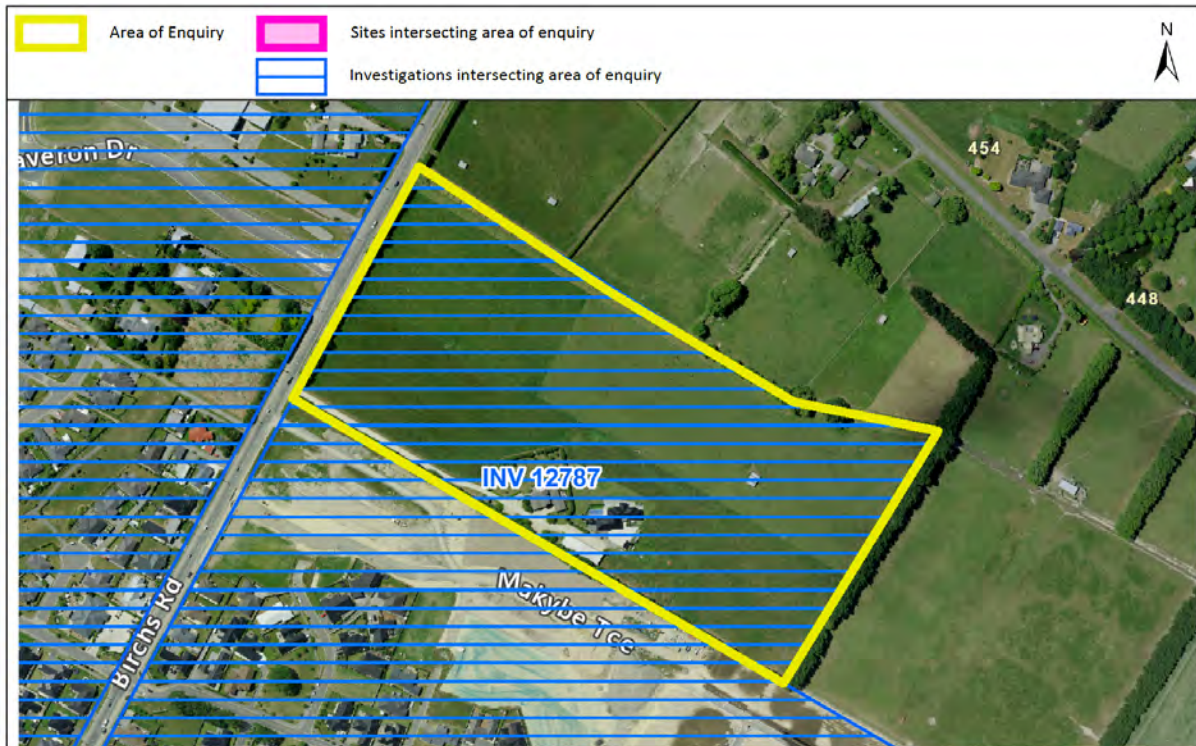
The site is not currently listed on the Environment Canterbury (ECAN) Listed Land Use Register as potentially contaminated. The LLUR lists a desktop-based ground contamination assessment has been conducted at the site, and nearby sites, by Tonkin & Taylor as part of a rezoning effort, namely "Plan Change 7", in Lincoln and Rolleston. The site was identified as having "dwelling and farm sheds" as potential sources of environmental contamination.

Figure 3: LLUR Map of Property (image source: Environment Canterbury LLUR)

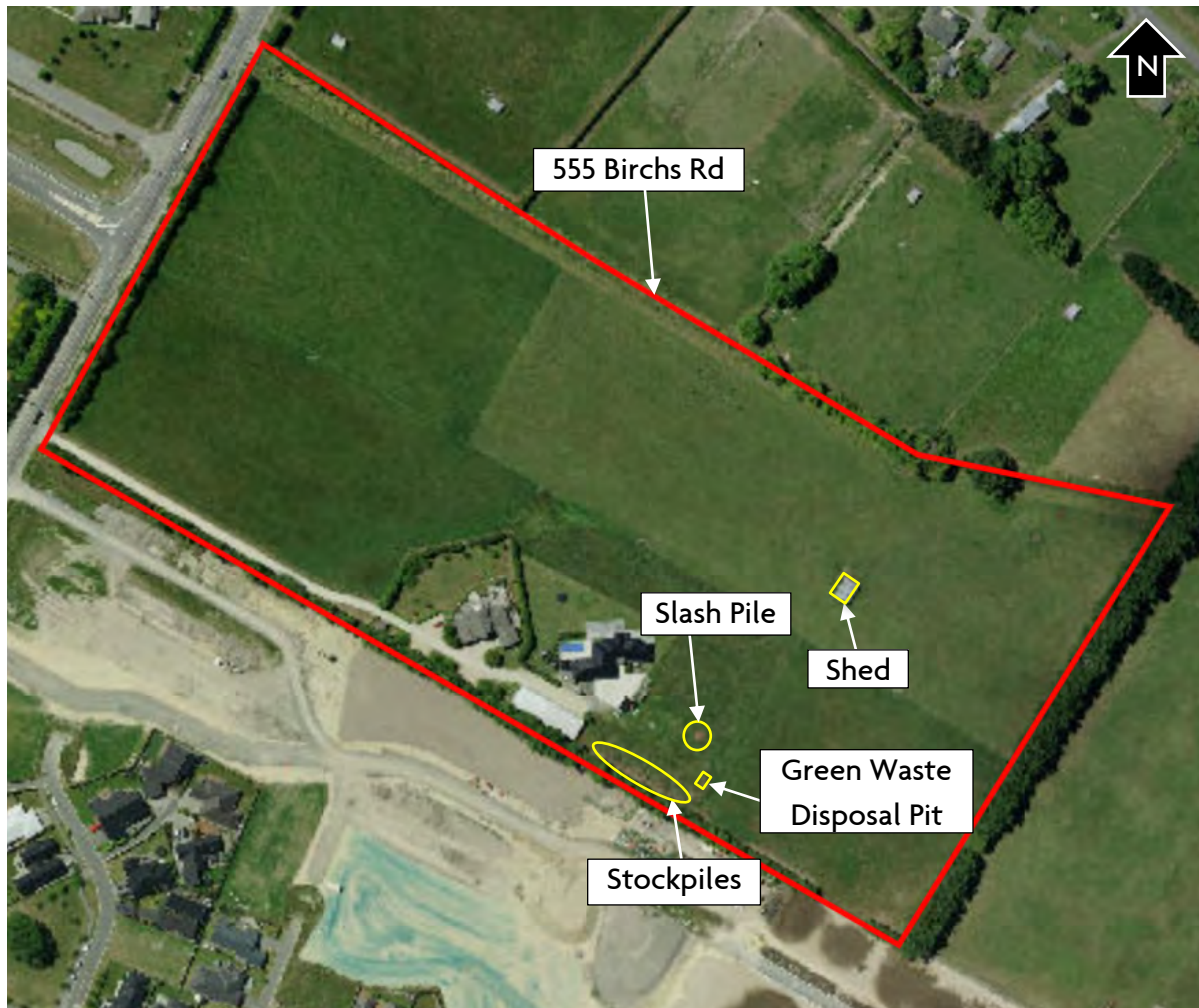
A green waste disposal pit (Figure 4) approximately 2 m wide by 4 m long was discovered at the eastern end of the stockpile. The pit contained leaves and grass clippings. The site owner informed Sephira Environmental personnel that the pit was excavated for the purpose of creating an area where grass clippings, and other slash, could be managed. No anthropogenic debris was said to be disposed of in the pit. The soil excavated from the pit

**Figure 4: Identified Features (base image source: [mapviewer.canterburymaps.govt.nz](https://mapviewer.canterburymaps.govt.nz))**

The burn pile identified in recent aerial photographs (Figure 4) was approximately 2 m circular diameter and contained unburned branches and slash. No evidence of charred, or anthropogenic material was observed in the pile. Grass had weaved its way into the base of the slash pile, indicating it had been in that state for an extended period of time. The owner of the site informed Sephira Environmental personnel that the pile had never been burnt and had been at the site for at around 3 years. With no physical evidence of anthropogenic debris or material being burnt at this location, no sampling was deemed necessary at the slash pile.

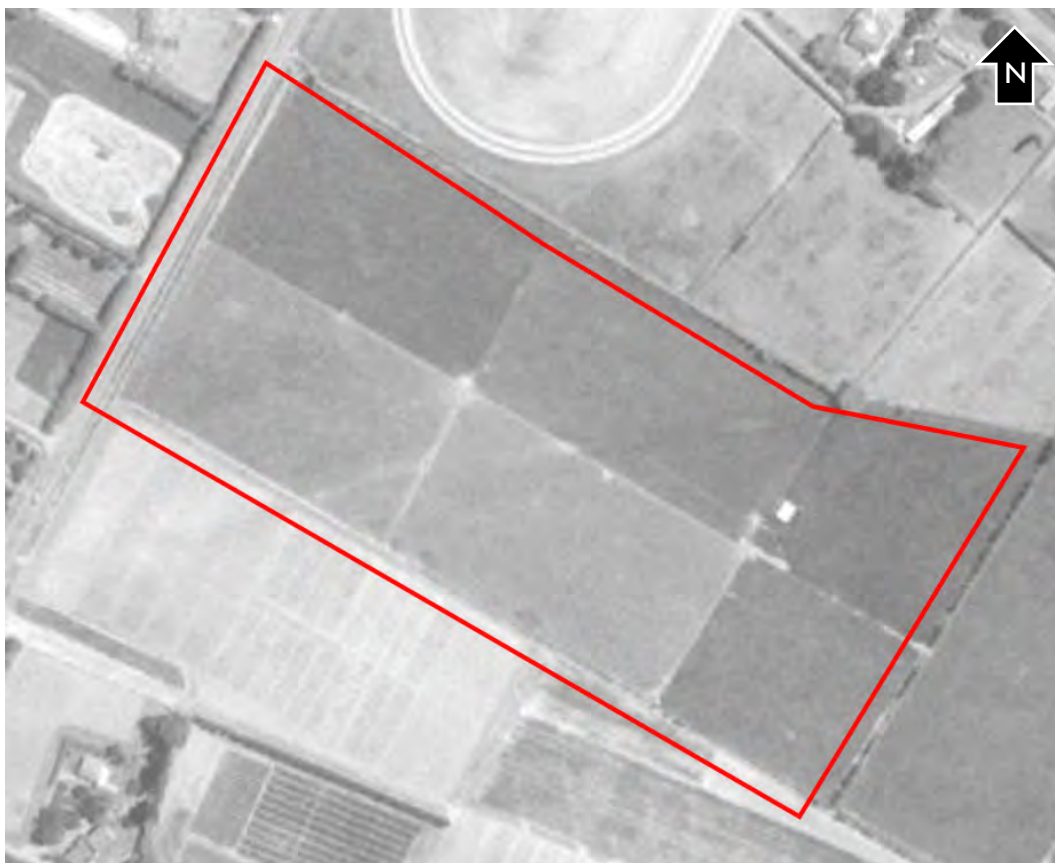
In 1994 the site is split up into 6 smaller paddocks. A shed appears in the central south-western area of the site. The site remains the same until 2000 where a second shed appears along the southern boundary of the site.

Figure C-5. 1994 Aerial Photograph (base map source: mapviewer.canterburymaps.govt.nz)

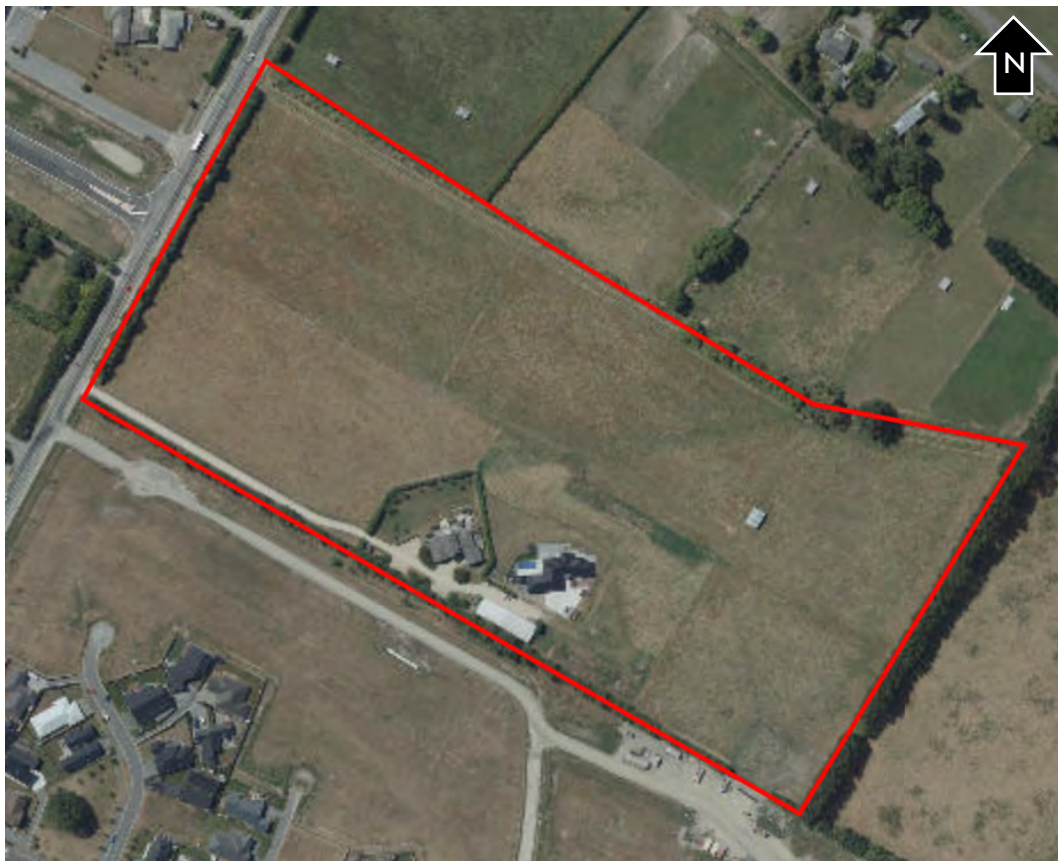
A second residence appears at the site in 2019 directly to the east of the first residence. Evidence of possible earth disturbance and/or stockpiling of unknown materials can also be seen in this image just beyond the eastern end of the secondary shed, running approximately 45 m in length, along the southern boundary. A potential burn pile is also present nearby the eastern end of the area of earth disturbance/stockpiles. These identified features are present at the site in the most recent available image from 2020.

Figure C-10. 2019 Aerial Photograph (base map source: [mapviewer.canterburymaps.govt.nz](http://mapviewer.canterburymaps.govt.nz))

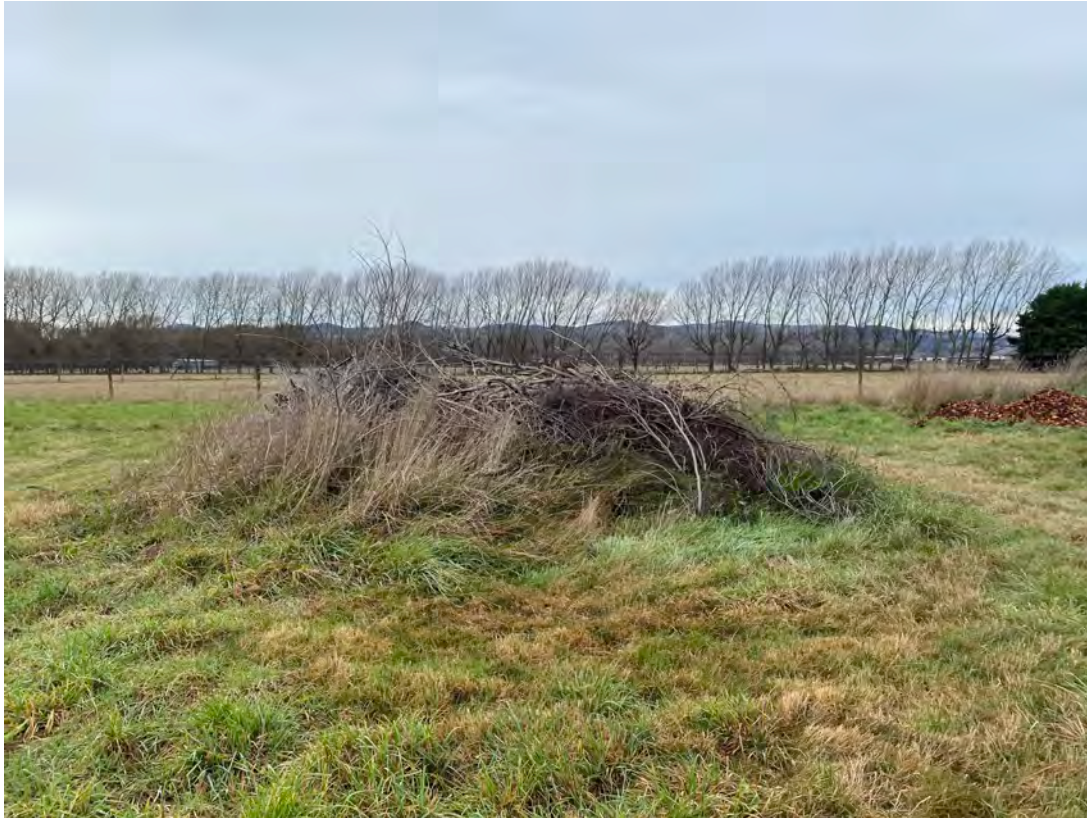
**Figure D-1. Suspected burn pile which is a slash pile, never burnt, near the southern site boundary.**

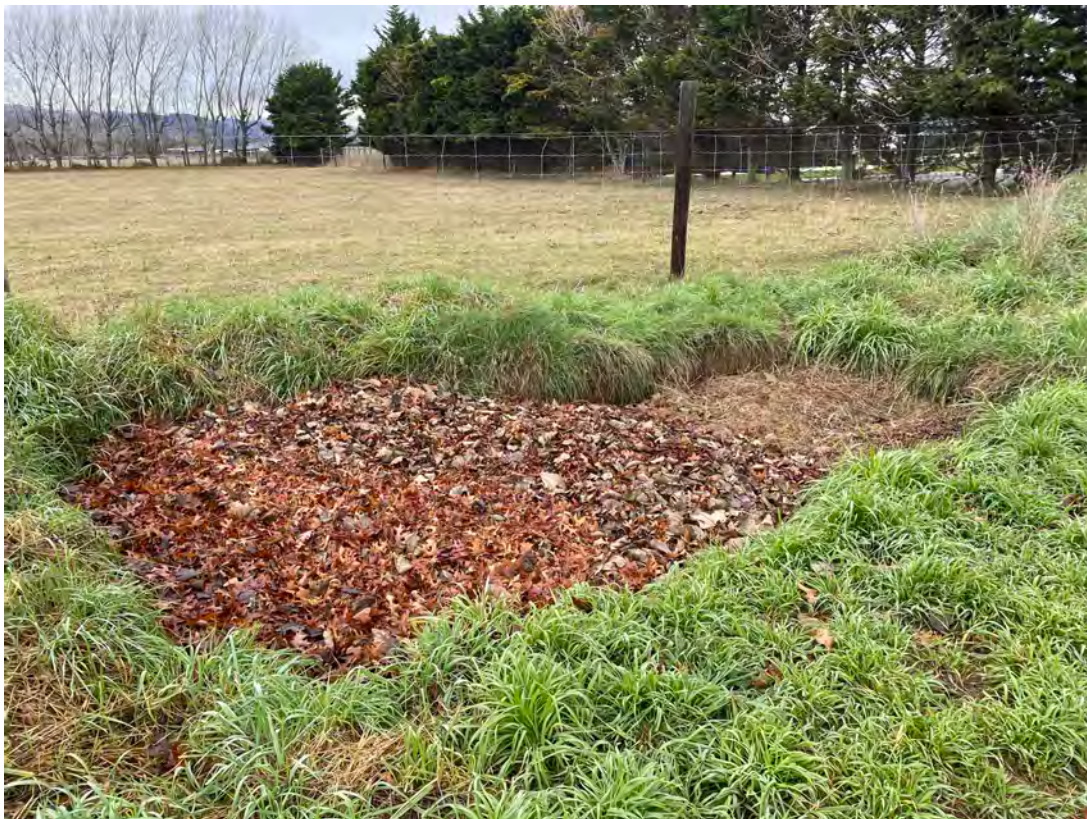
**Figure D-2. Green waste disposal pit at near the southern boundary of the site.**

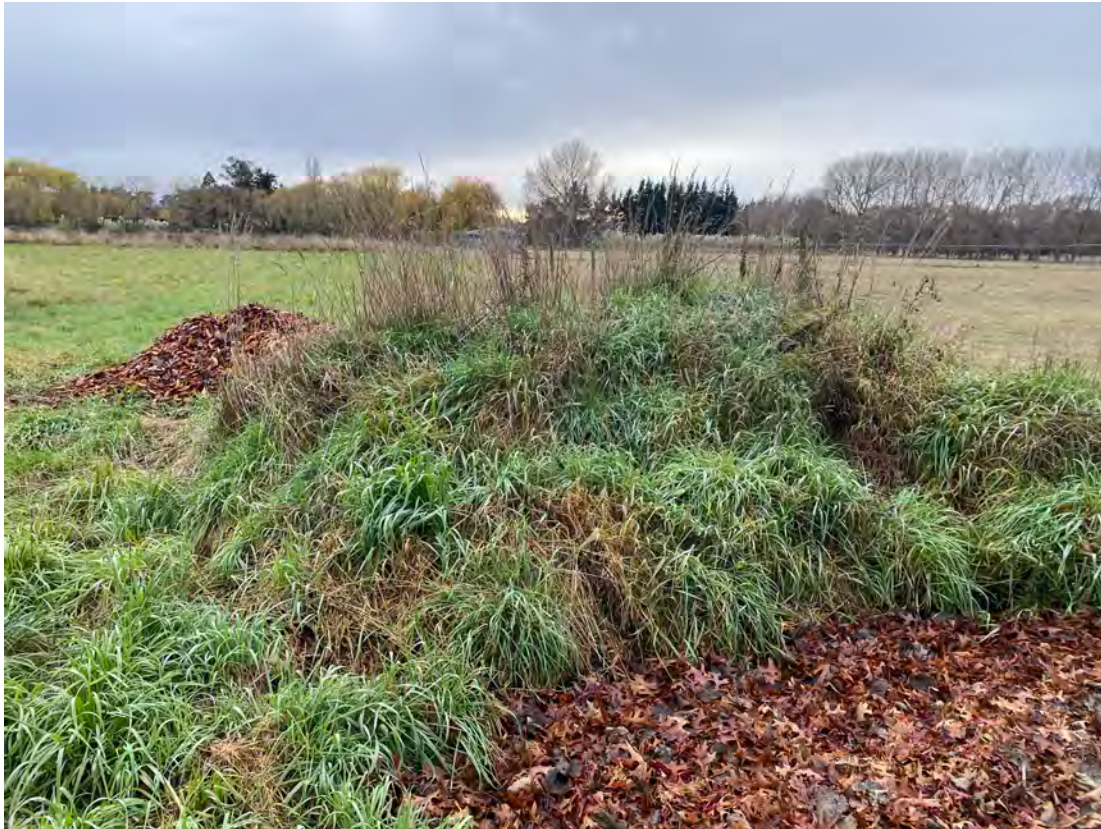
was placed in a grassed stockpile next to the hole. Sephira Environmental personnel used a post hole digger to investigate the material in the pit, which was indeed decaying organic matter. No anthropogenic debris was observed in the pit, therefore no sample was collected from this location.

Figure D-3. Soil excavated to create the green waste disposal pit next to the pit.

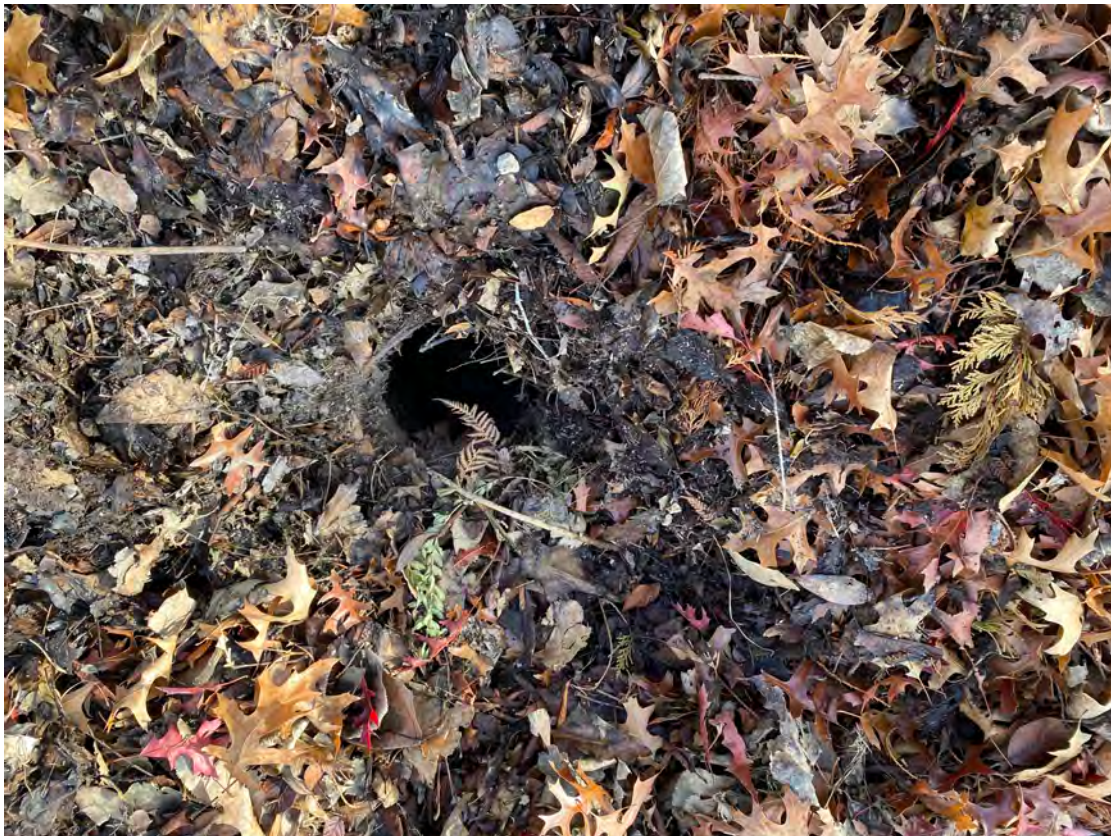
Figure D-4. Close up of post hole excavation into green waste disposal pit.

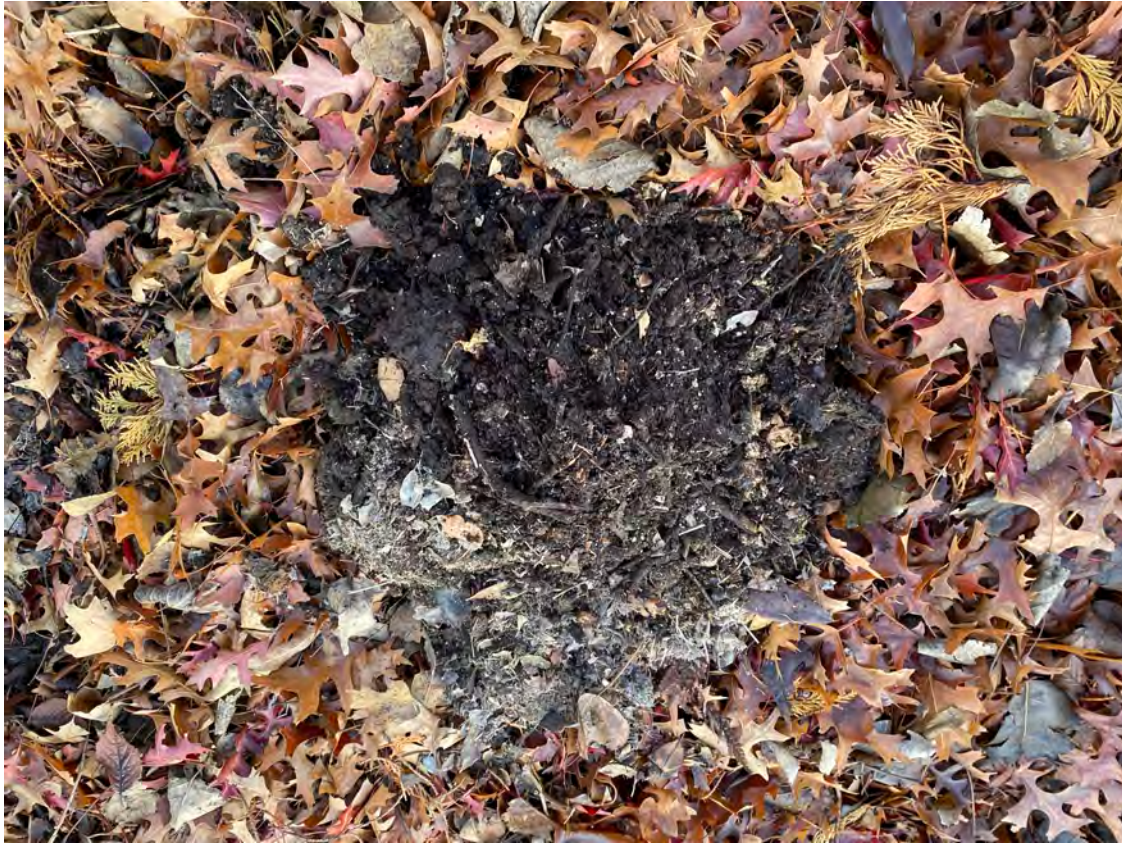
Figure D-5. Material excavated from post hole into green waste disposal pit.

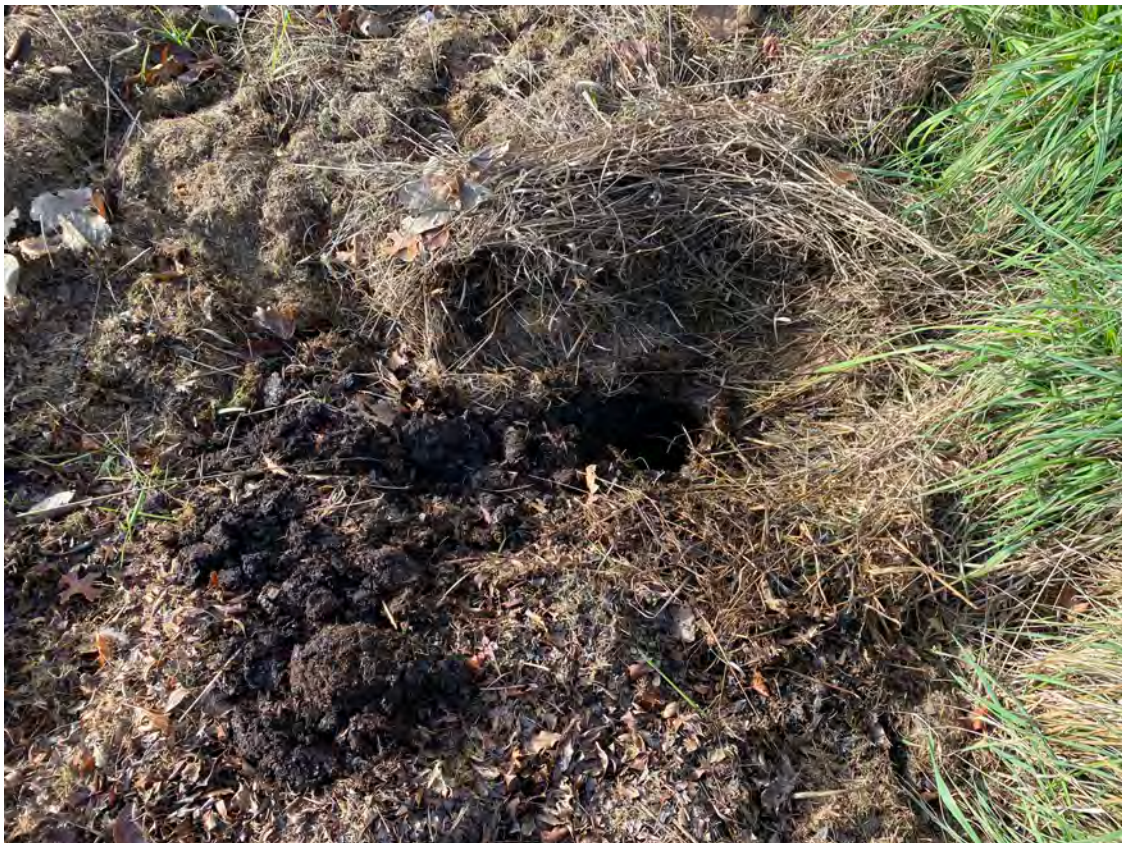
Figure D-6. Secondary post hole location in green waste disposal pit, and excavated material.

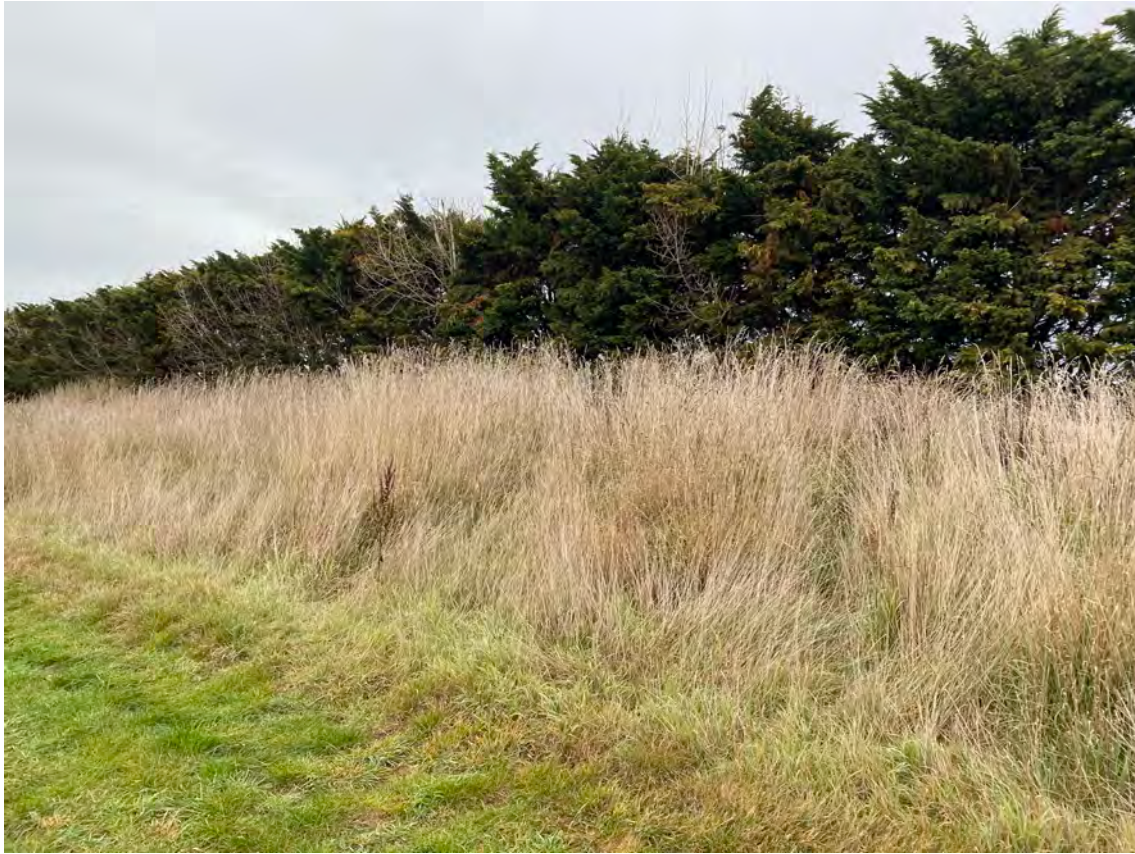
The owner of the site came out and spoke with Sephira Environmental personnel when investigation into the stockpiled soil bund was occurring. The location of the stockpile is shown on Figure 4. He informed Sephira Environmental personnel the soil came from the construction of the second residence at the site. Instead of disposing of the soil off-site it was decided to place the soil in the bund. No evidence of anthropogenic material was seen in the stockpile, nor was it observed during its placement by the owner of the site. The soil was observed to be a dry, tan-grey silt. No sampling was conducted at the stockpiled soil bund as the origin of the soil was discovered.

**Figure D-7. Stockpile of soil along southern boundary of the site.**

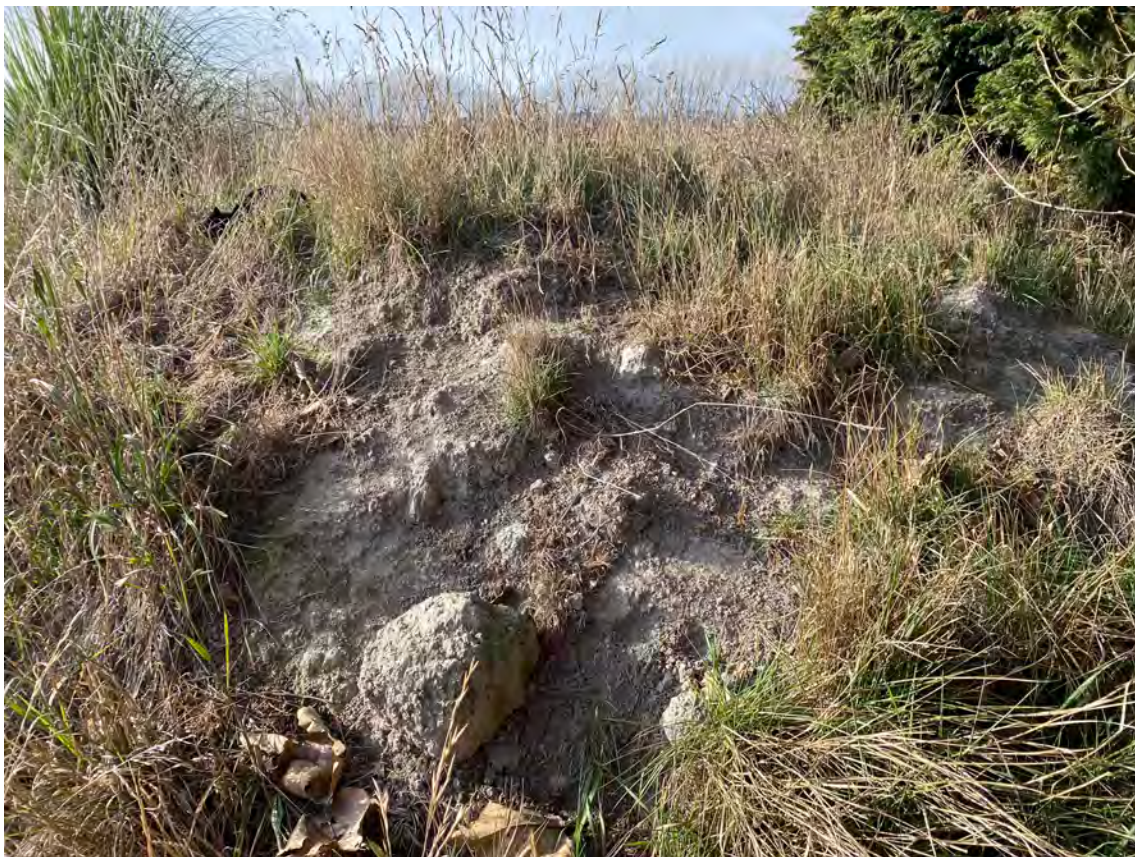
**Figure D-8. Close up of silt making up the stockpiled soil.**

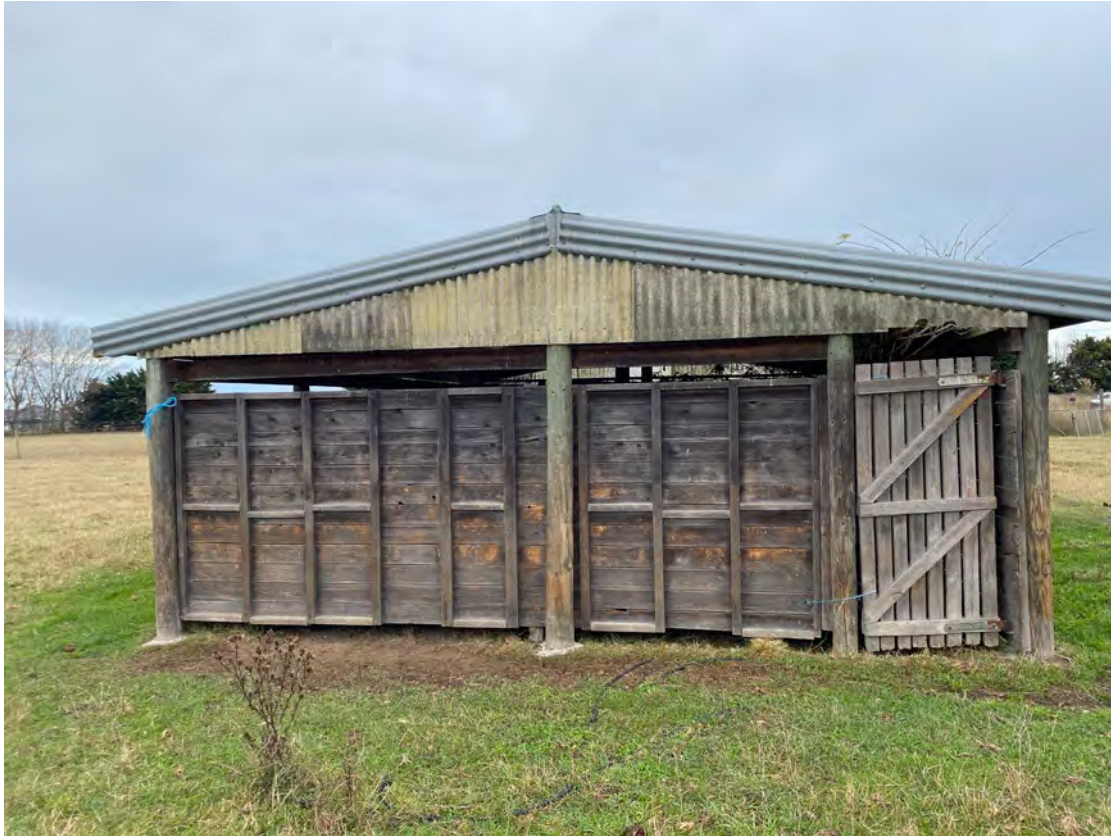
The pre-2000's shed in the centre of the site was constructed with unpainted corrugated metal roofing, and unpainted metal and wooden walls and an earthen floor. The materials were in good condition, and no potential ACM was observed in the building materials. Therefore, the potential for asbestos and/or lead contamination associated with these pre-2000 sheds was eliminated. The shed was empty at the time of the site walkover, however it appeared to be as animal shelter.

Figure D-9. Unpainted pre 2000's shed in the centre of the site.
