## **GEOTECHNICAL INVESTIGATION REPORT**

### **FOR PROPOSED RESIDENTIAL SUBDIVISION**

555 Birchs Road, Lincoln, Selwyn

Project Reference: LTC24135

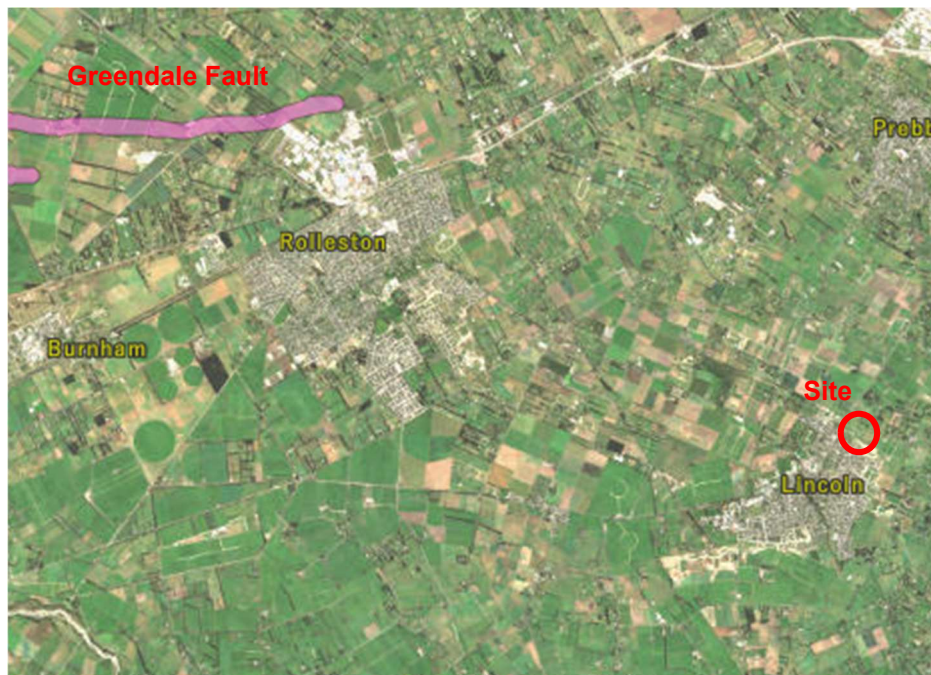
**Figure 2: Canterbury Maps image showing site in relation to the Greendale Fault**

The Greendale Fault and associated blind faults of the Darfield earthquake sequence have been defined by GNS Science via field inspection, aerial photography interpretation and geologic mapping. The GNS report indicates that these faults were unknown prior to 2010 and that the ages of previous ruptures therefore are also not known. This leaves the potential for further unmapped faults to exist within the locality of the investigation site. The report suggests that the magnitude of large earthquakes along Greendale Fault could be on the order of 7.0M, as observed during the CES. The estimated Recurrence Interval (RI) of the Greendale Fault is between 5,000 and 10,000 years (RI class IV).

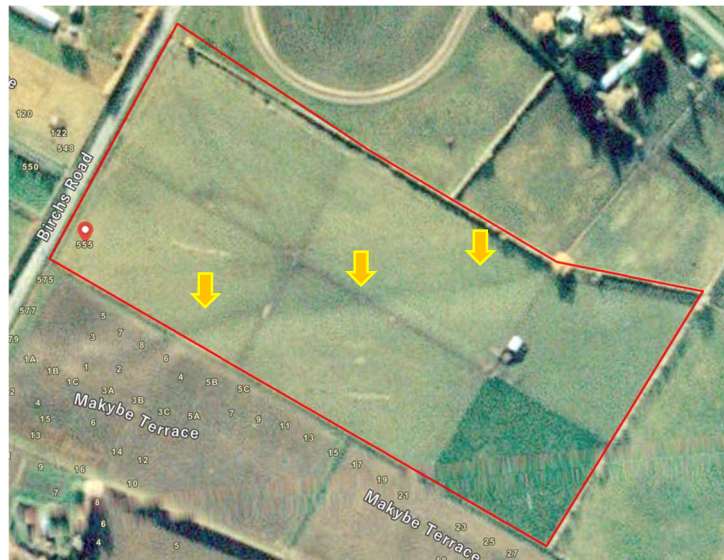
**Figure 3: Photo sourced from Canterbury Maps showing apparent drainage feature (arrows),**

- We have referred to online data to assess the surface expression of liquefaction and liquefaction-induced ground damage observed on and near the site during the Canterbury Earthquake Sequence (CES)<sup>12</sup>. A review of aerial photography of rural Canterbury, including the area of the site, was completed by GNS following the September 2010 and February 2011 earthquake events. The mapped data from the GNS review (accessed via Canterbury Maps) indicates that flooding was identified in the centre of the site, within an apparent channel/swale feature following the September 2010 CES event.

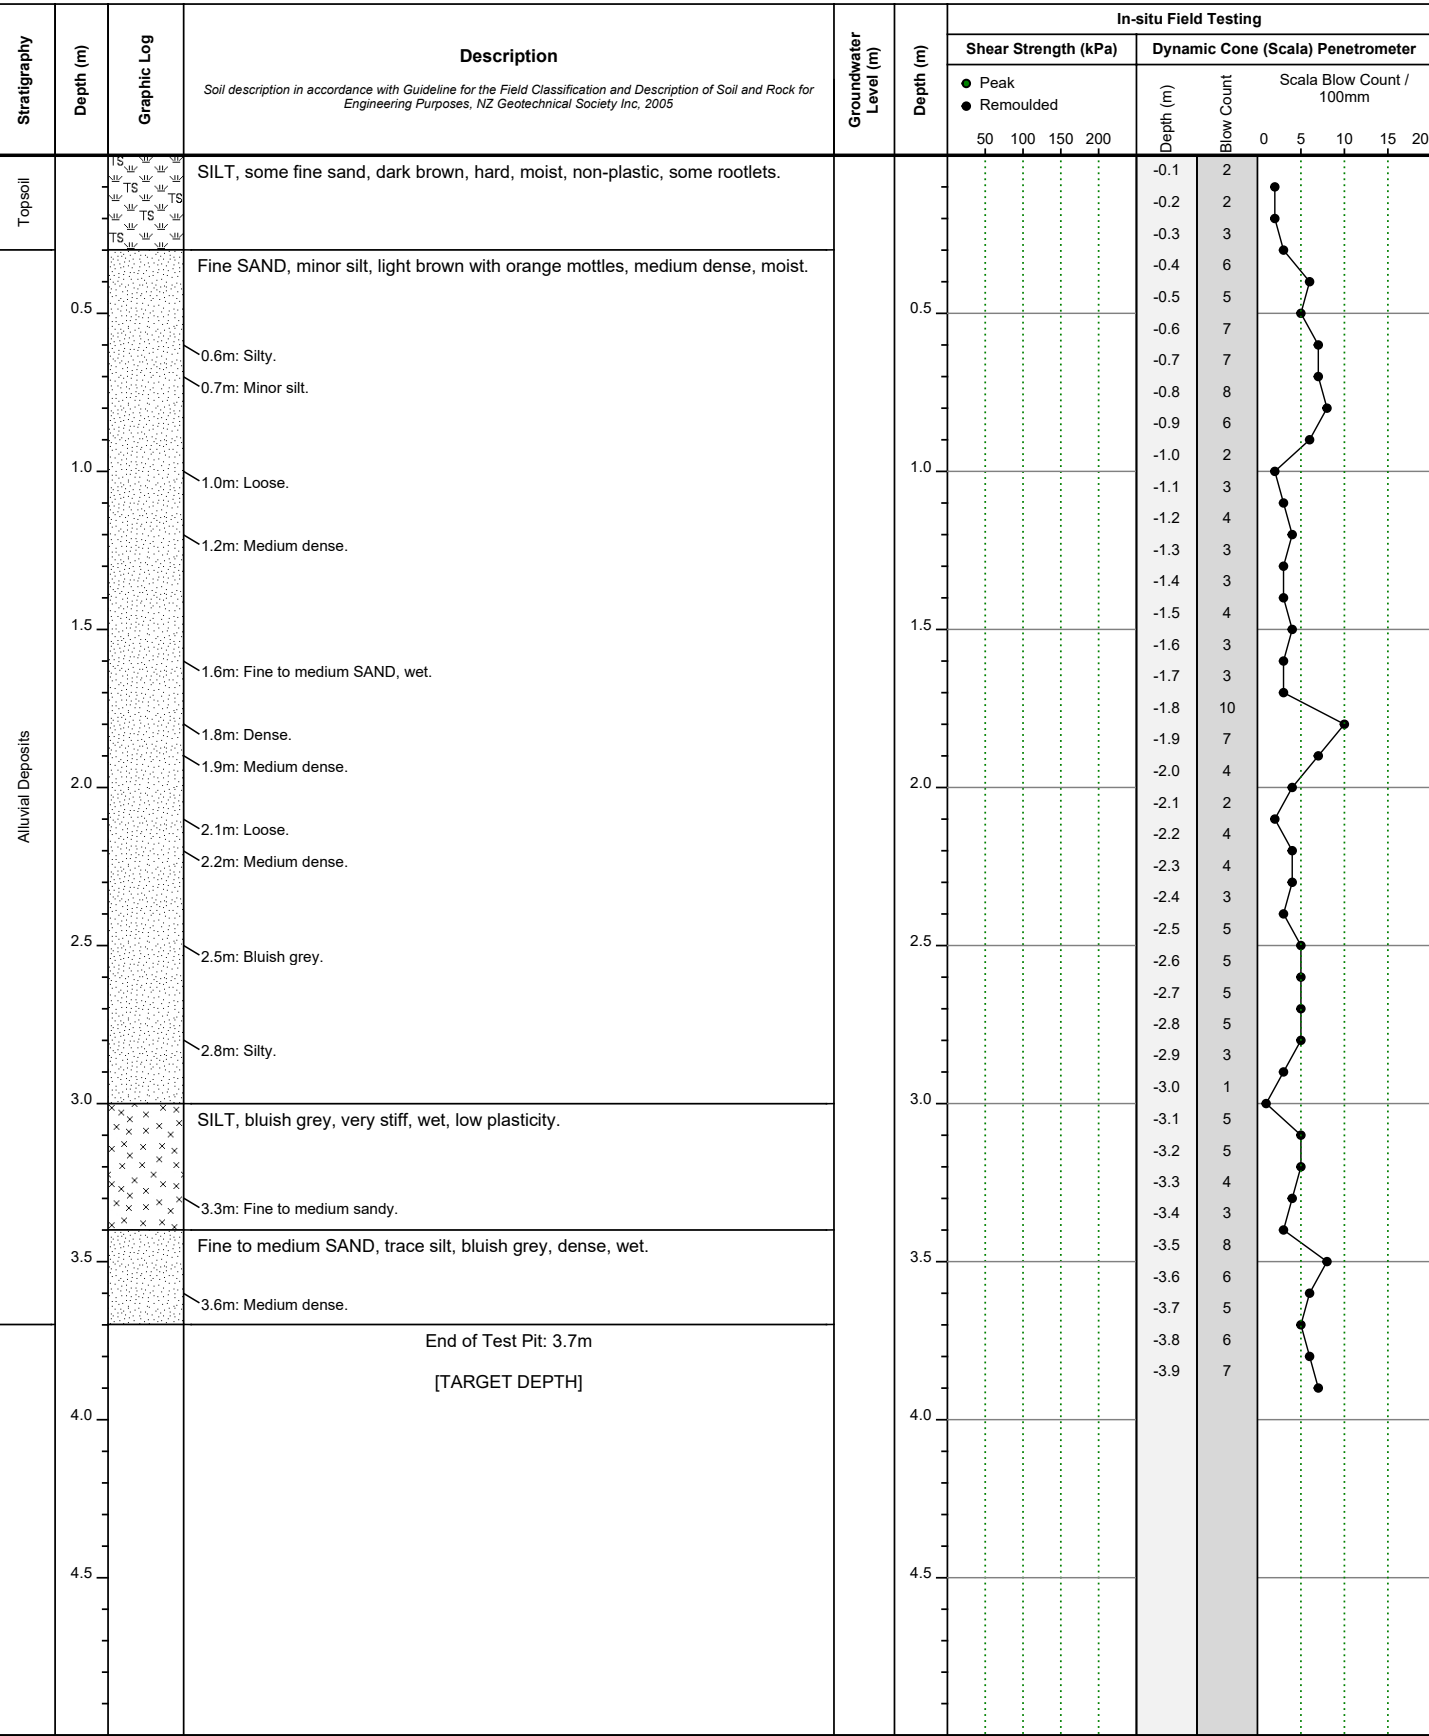
Target depth Achieved  
Piezo ground water level reading 06/06/24: n/a piezo was dry  
Piezo ground water level reading 10/06/24: 2.65m

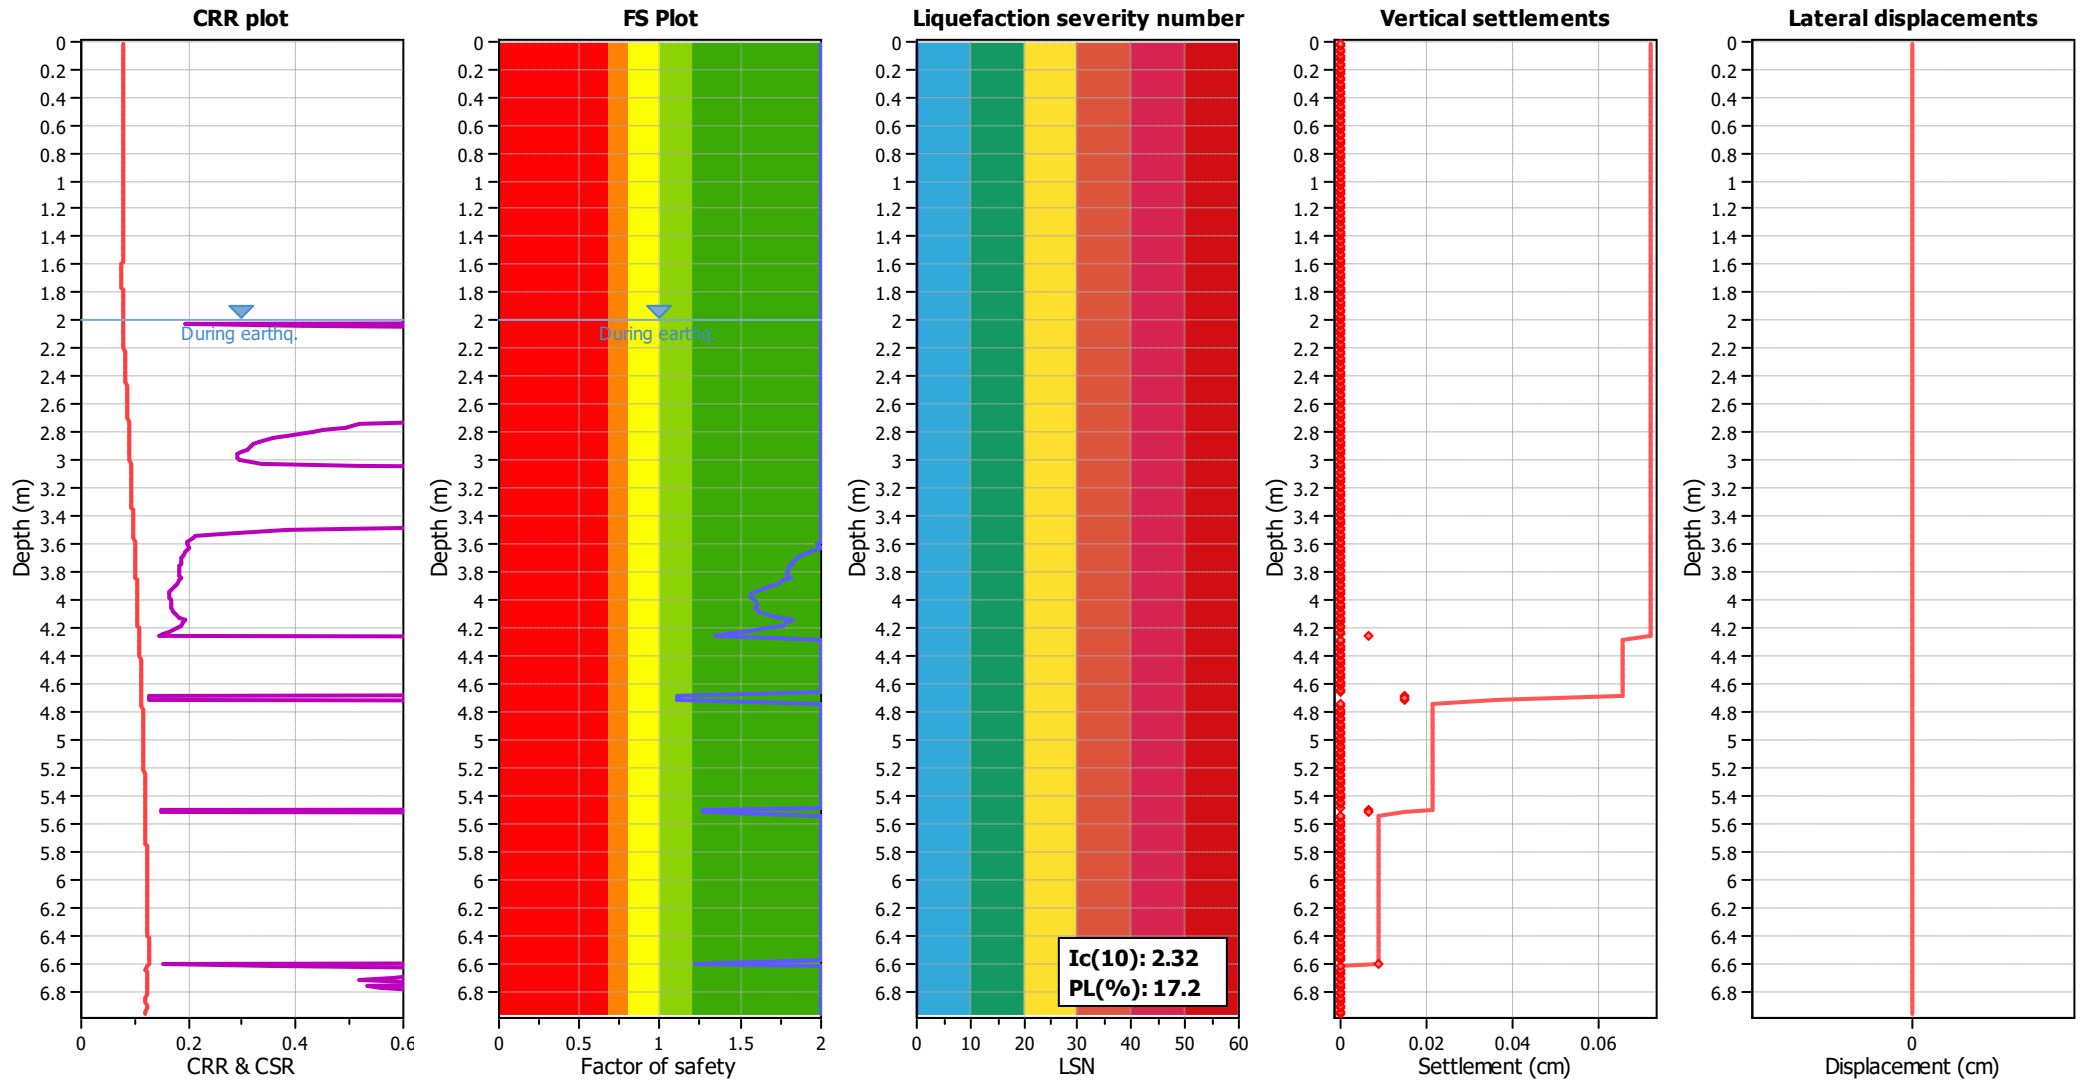
Liquefaction analysis overall plots

| Analysis method: | B&I (2014) | Depth to GWT (earthq.): | 2.00 m | Fill weight: | N/A |

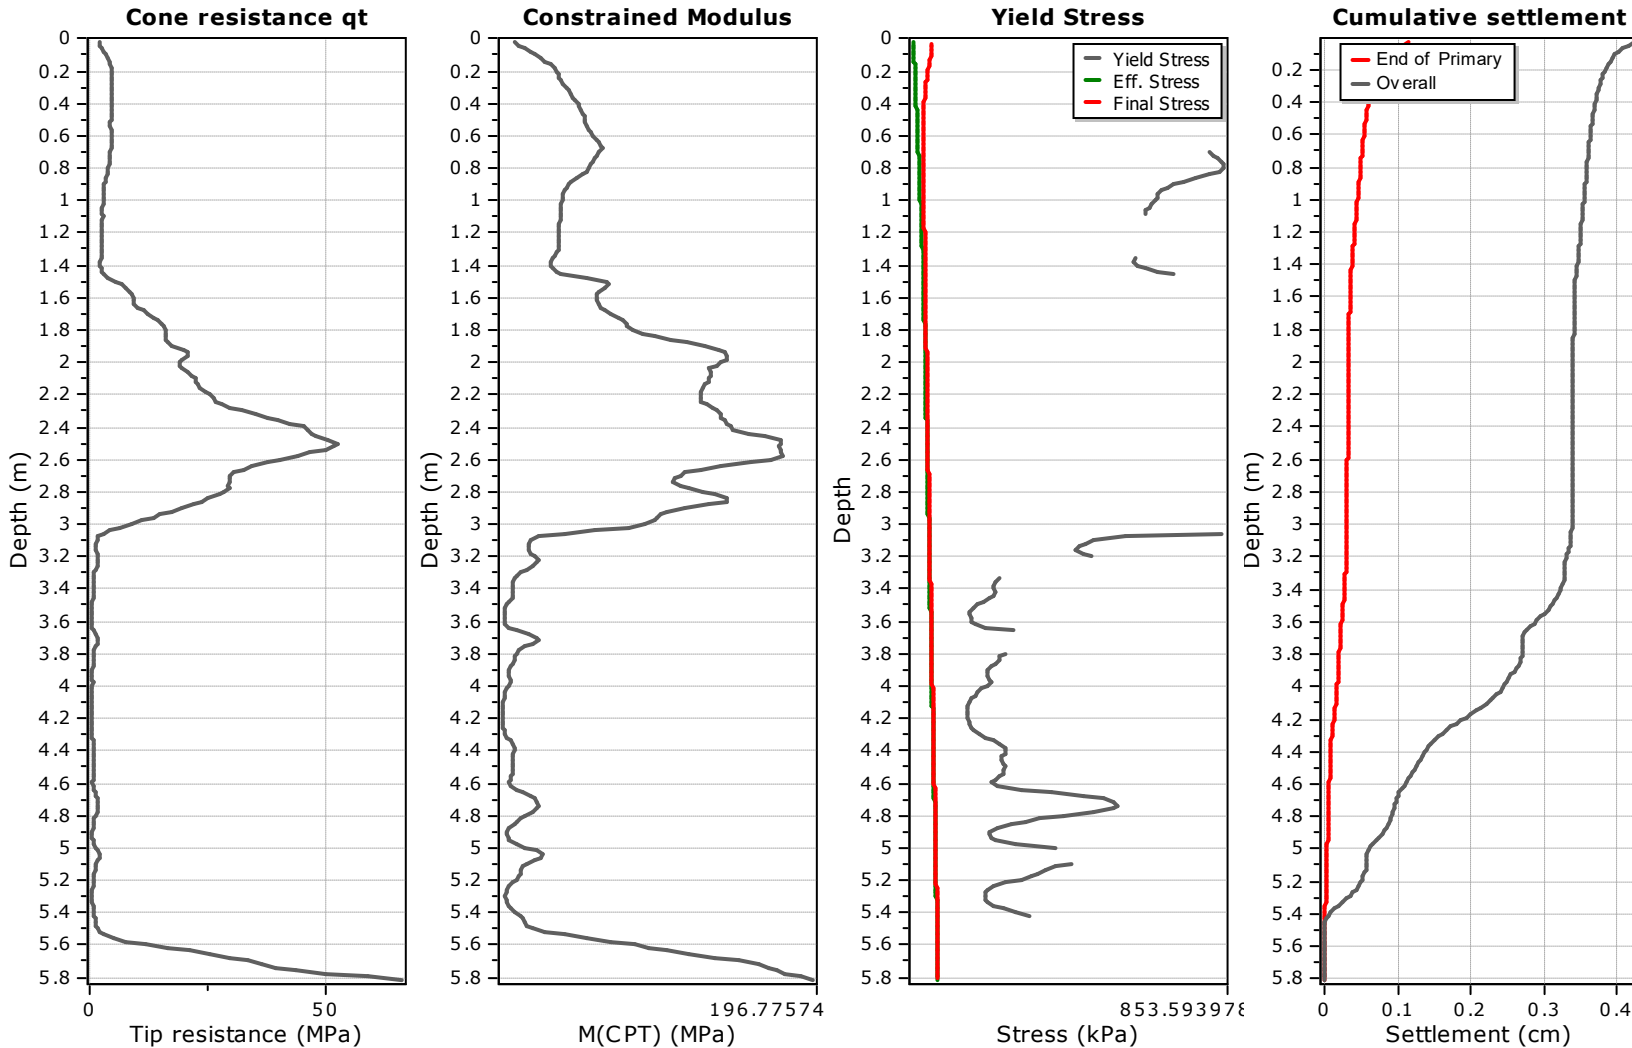
### Settlements calculation according to theory of elasticity\*

Footing type: Rectangular  
Footing width: 0.30 (m)  
L/B: 10.0  
Footing pressure: 50.00 (kPa)  
Embedment depth: 0.00 (m)  
Footing is rigid: No  
Remove excavation load: No  
Apply 20% rule: No  
Calculate secondary settlements: Yes  
Time period for primary consolidation: 6 months  
Time period for second. settlements: 1200 months
