# Land Information Memorandum L261193

| <b>Location</b> | 572 Selwyn Road |
| <b>Legal Description</b> | Lot 2002 DP 600834 |

### **Geotechnical Investigation**

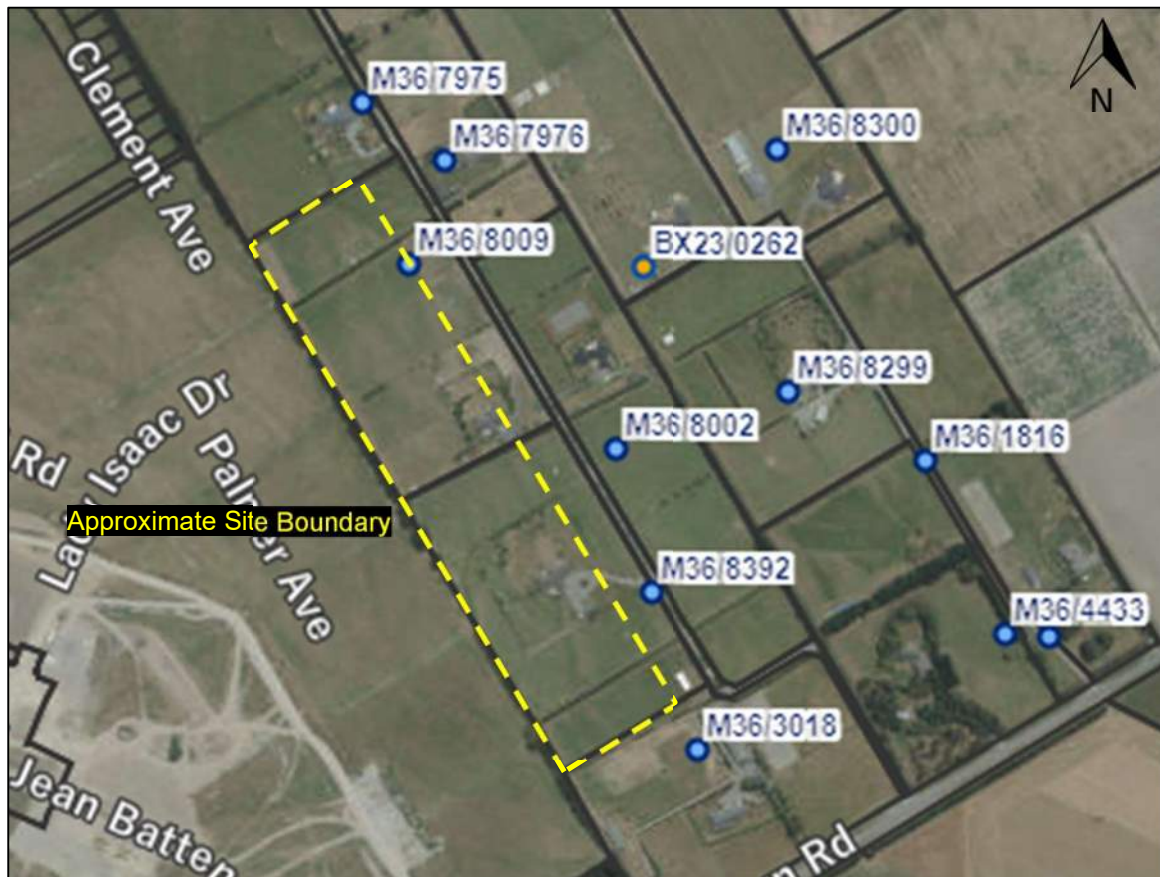
**Figure 2: Nearby ECan Borehole Locations**

Aerial photograph sourced from Canterbury Maps. Not to scale.

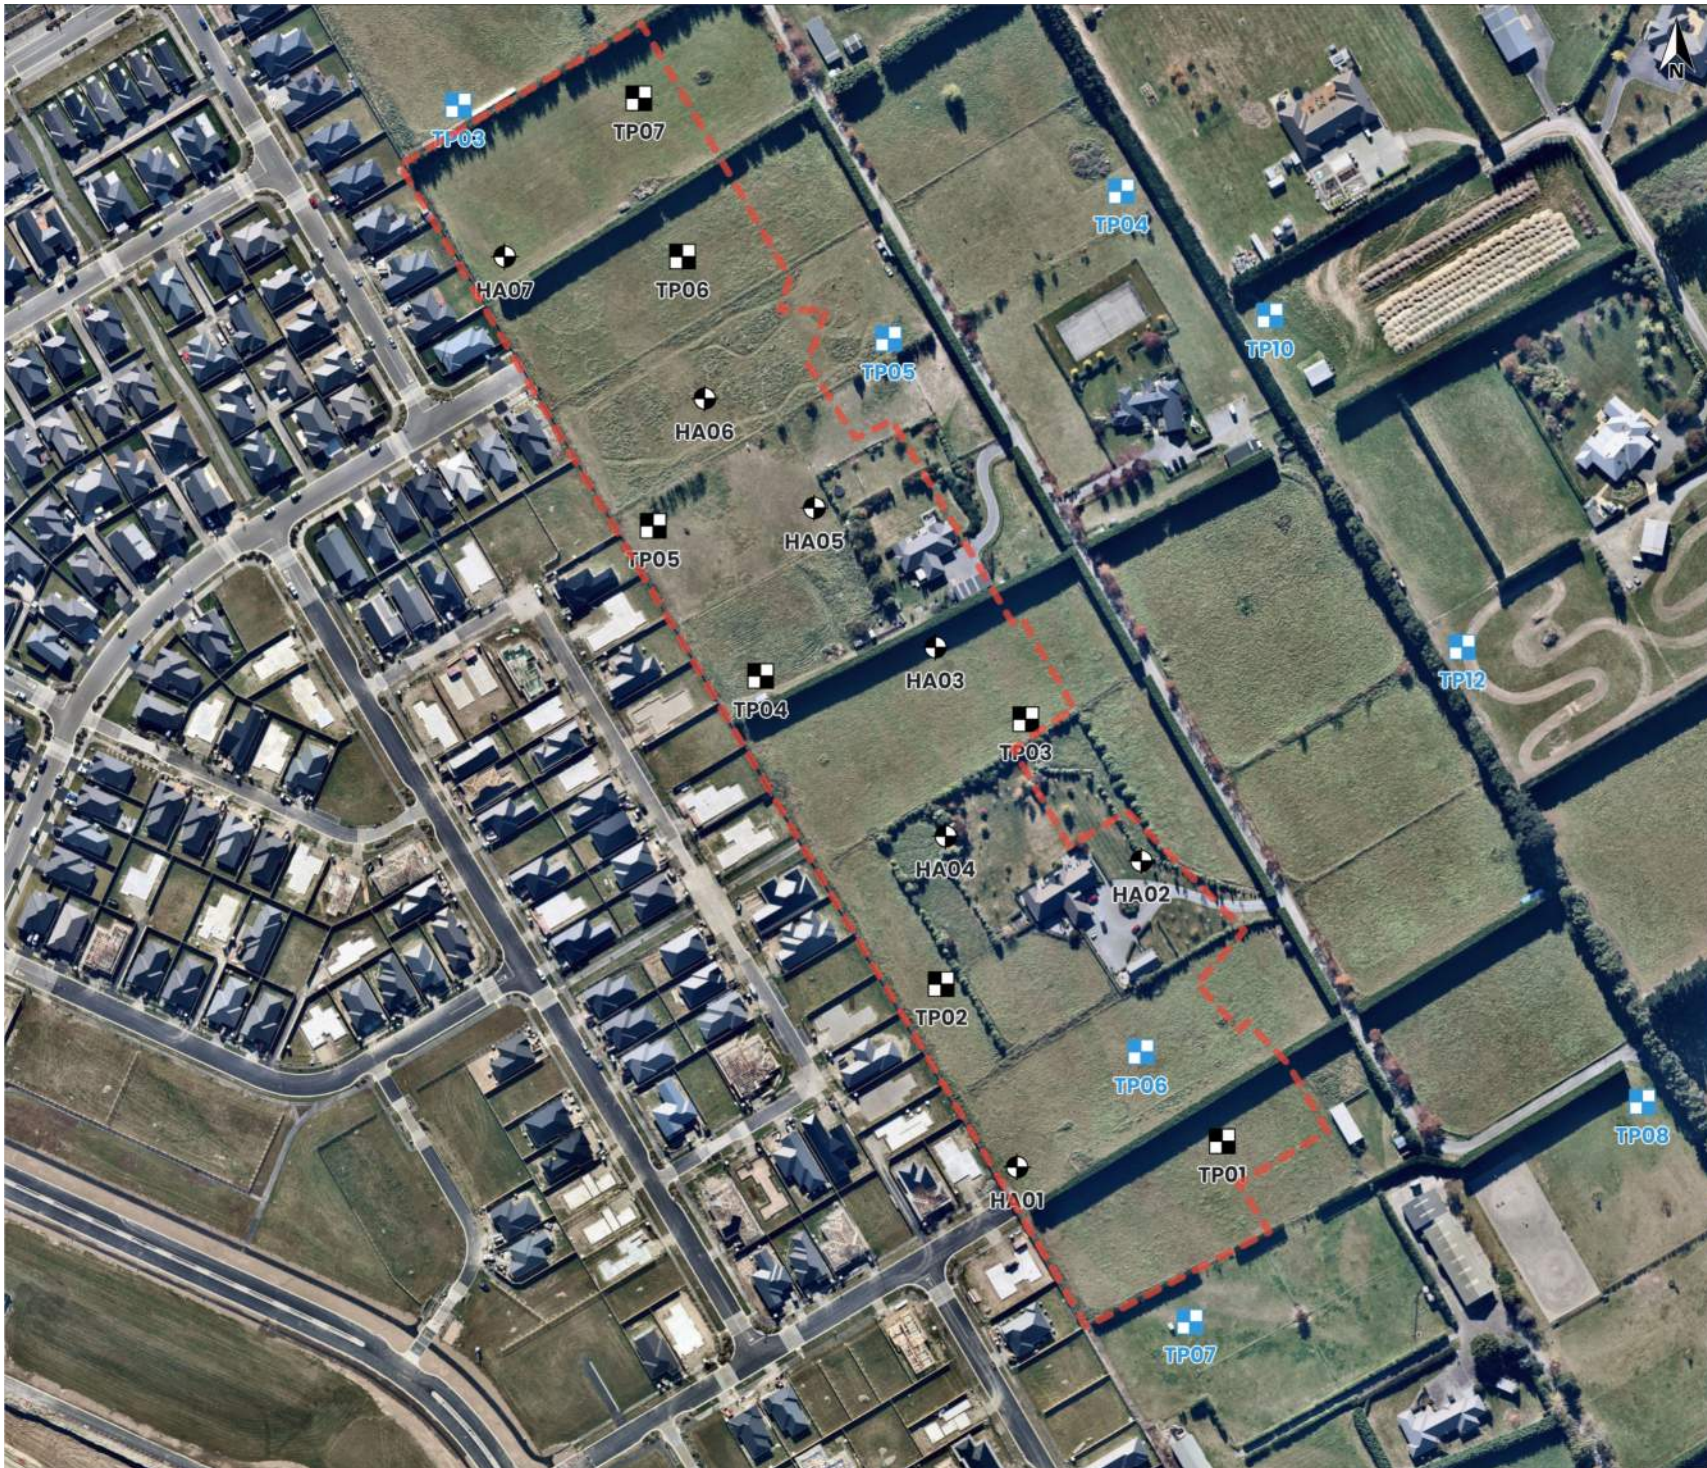
### Site Plan and Subsurface Investigation

- Legend**
- Site Boundary
  - 2020 Plan Change Testing (ENGEO)
  - 2022 Test Pit Excavations
  - 2022 Hand Auger Tests

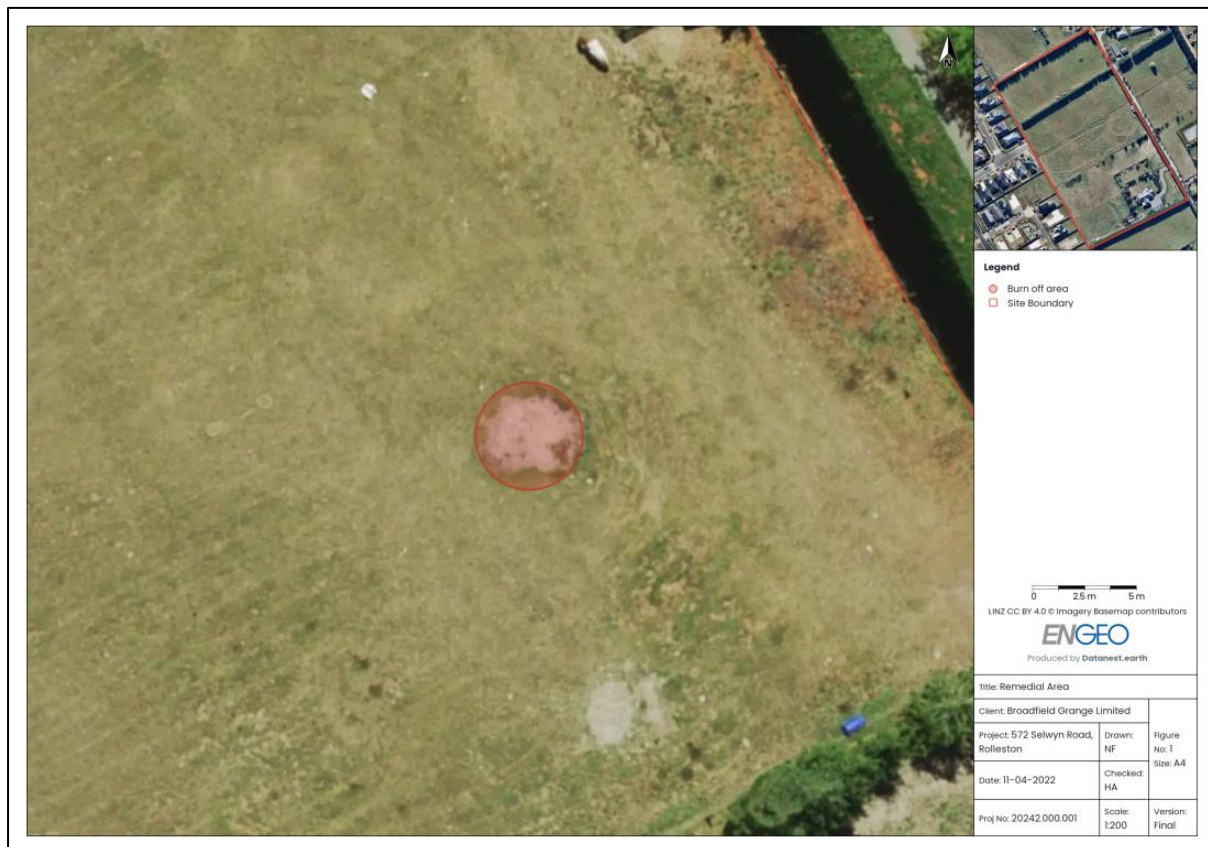
**Figure 1: Remedial Area**

The remedial area at 4/572 Selwyn Road is included in Figure 1 below.

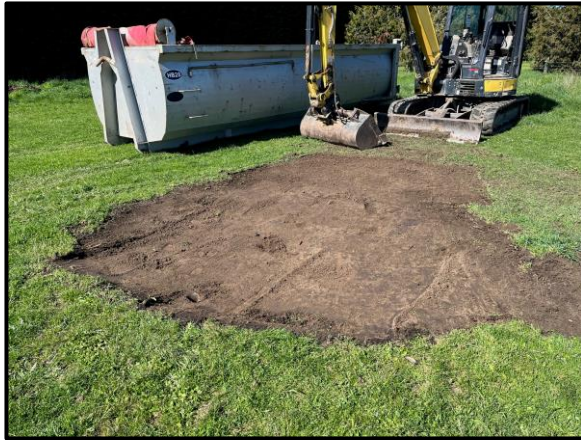
The site photographs below show the remedial area after the excavation of the contaminated material and Figure 3 below shows the sample location plan.

Photo 1: Remediated burn pile looking southeast

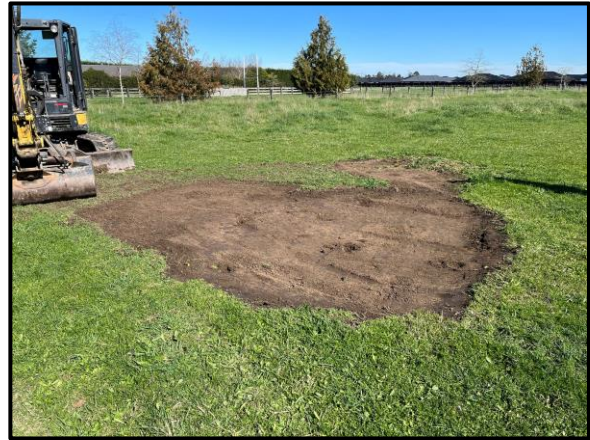
Photo 2: Remediated burn pile looking southwest
