**Project Number 29048.001.001**

**Geotechnical Investigation**

190 and 192 Hamptons Road, Prebbleton,  
Christchurch

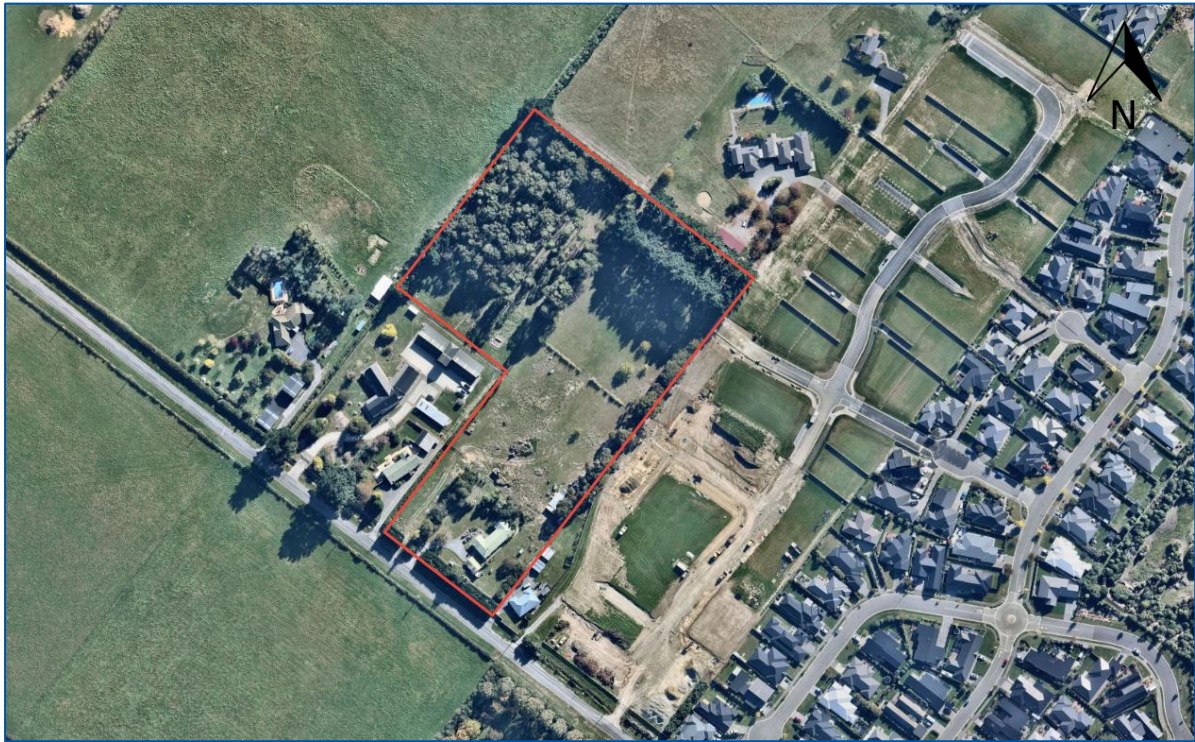
**Figure 1: Site Plan**

The majority of the site is currently agricultural land mostly used for grazing. The site is bordered by Hamptons Road to the southwest, agricultural land to the northwest and northeast, and a recent subdivision development to the southeast. A residential dwelling and associated sheds are located in the southern area of the site.

Site Boundary shown in red

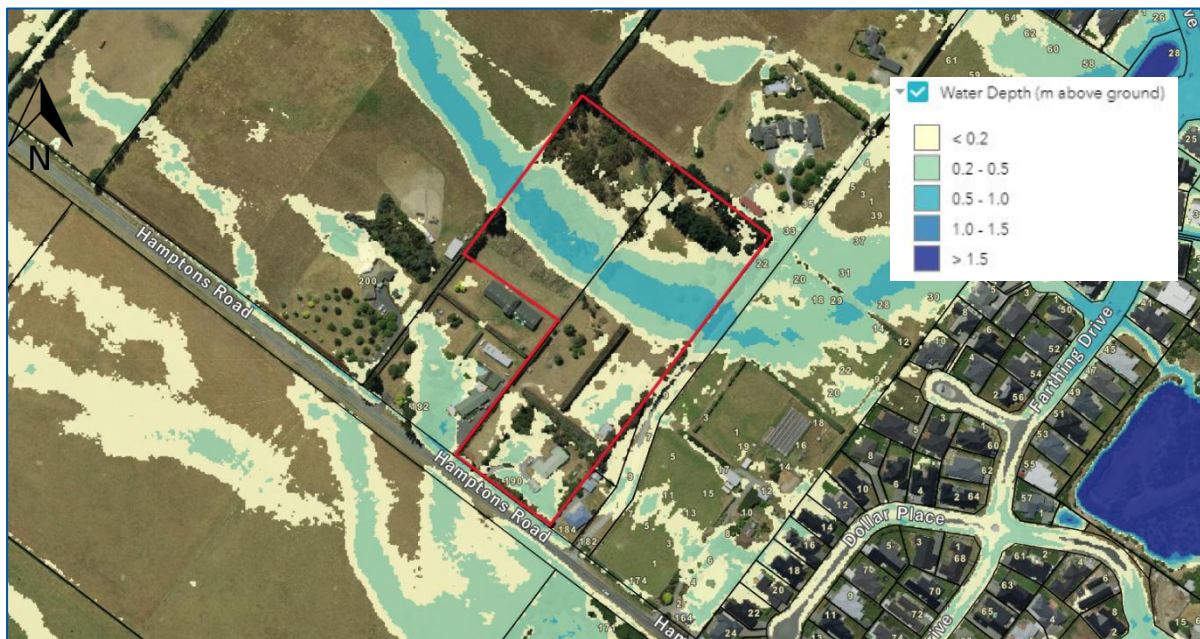
**Figure 3: Selwyn District Council Flooding Map (500-year flood event)**

The Selwyn District Council have carried out computer-based flood modelling to predict the extent and depth of flooding that could happen during a one-in-200-year and a one-in-500-year flood. Based on this modelling, the water depth through the site may be up to 1 m deep in the paleo channel feature discussed in Section 4.2 (Figure 3) during a 500-year flood event

Figure Notes

1. Site boundary shown in red
2. Aerial images sources from Canterbury Maps

We have not quantitatively assessed the risk of inundation from flooding as these assessments lie outside our scope for this geotechnical investigation. As mentioned in Section 3.6, the flood mapping by Selwyn's flooding and coastal hazards (Selwyn District Council, 2025) indicates that during a 1 in 200-year storm event, inundation of up to 1.0 m above ground level may occur, although it is mapped as being predominantly less than 0.2 m deep across much of the site. The risk of flooding on the site should be assessed by others.

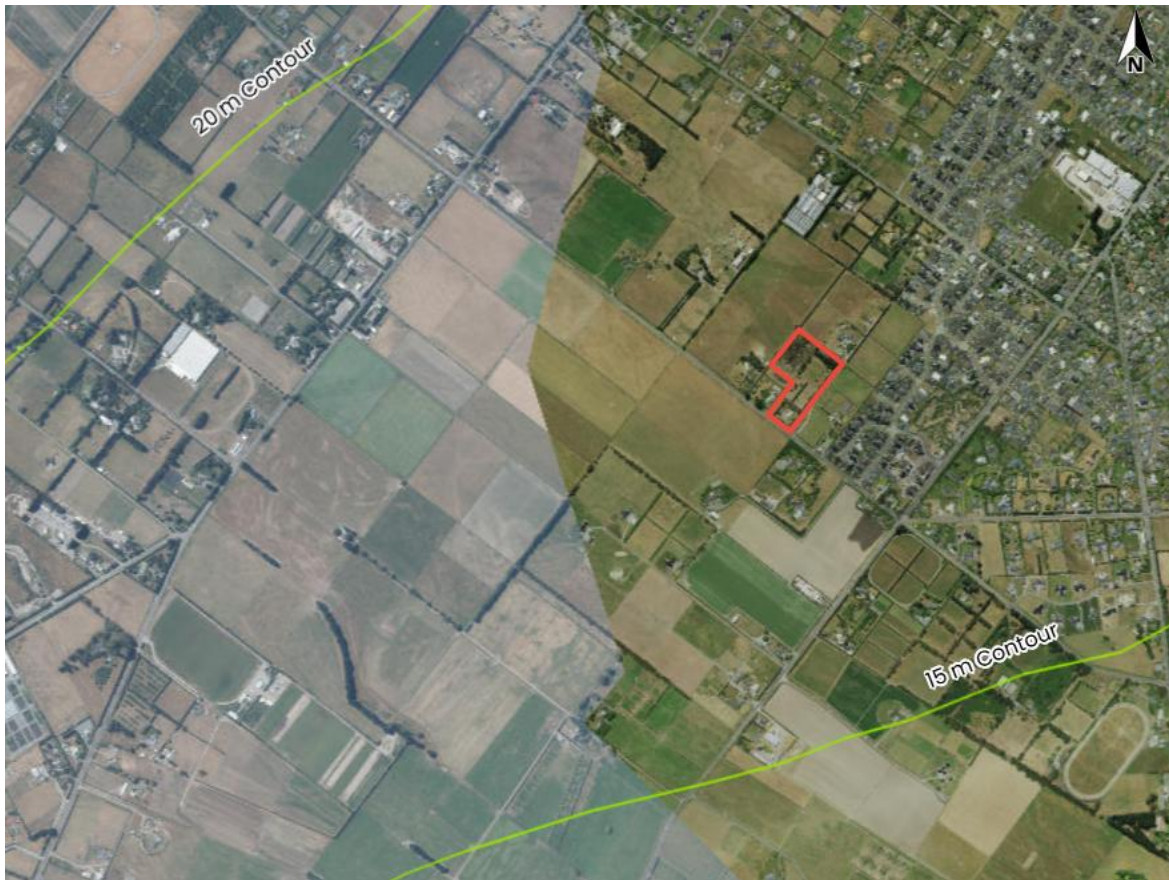
**Figure 4: ECan Regional Piezometric Elevation Contours**

Regional depth to groundwater contours available on Canterbury Maps indicate that groundwater beneath the site is approximately 7.0 m below ground level.

Figure Notes

1. Site boundary shown in red
2. Aerial images sources from Canterbury Maps

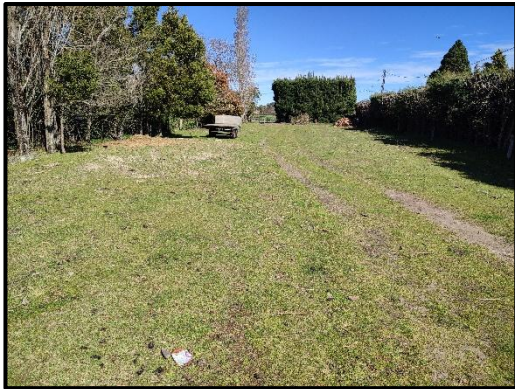
Photo 1: Site Access off Hamptons Road

- Recent site clearing to remove trees from the property had been partially completed at the time of our visit.
- The site is generally flat with several farm sheds along the east boundary of the site.
- A small amount of standing water was noted in the centre of the site.
- Established tree plantings were present in the north end of the site.

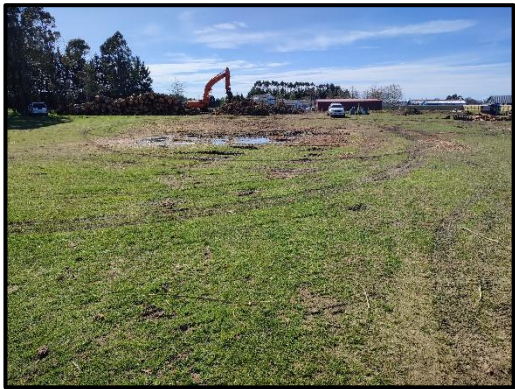
Photo 3: Standing water in centre of site.

- A soil bund was observed in the west end of the site in which material appeared to have been burned.
- Signs of surface drainage which may be related to the paleochannels identified in the aerial photo review were observed in the centre of the site. A fall in the land to the north was noticed from the hand auger locations of HA08 and HA14 (which were located within the location of an inferred paleochannel) towards the area of standing water.

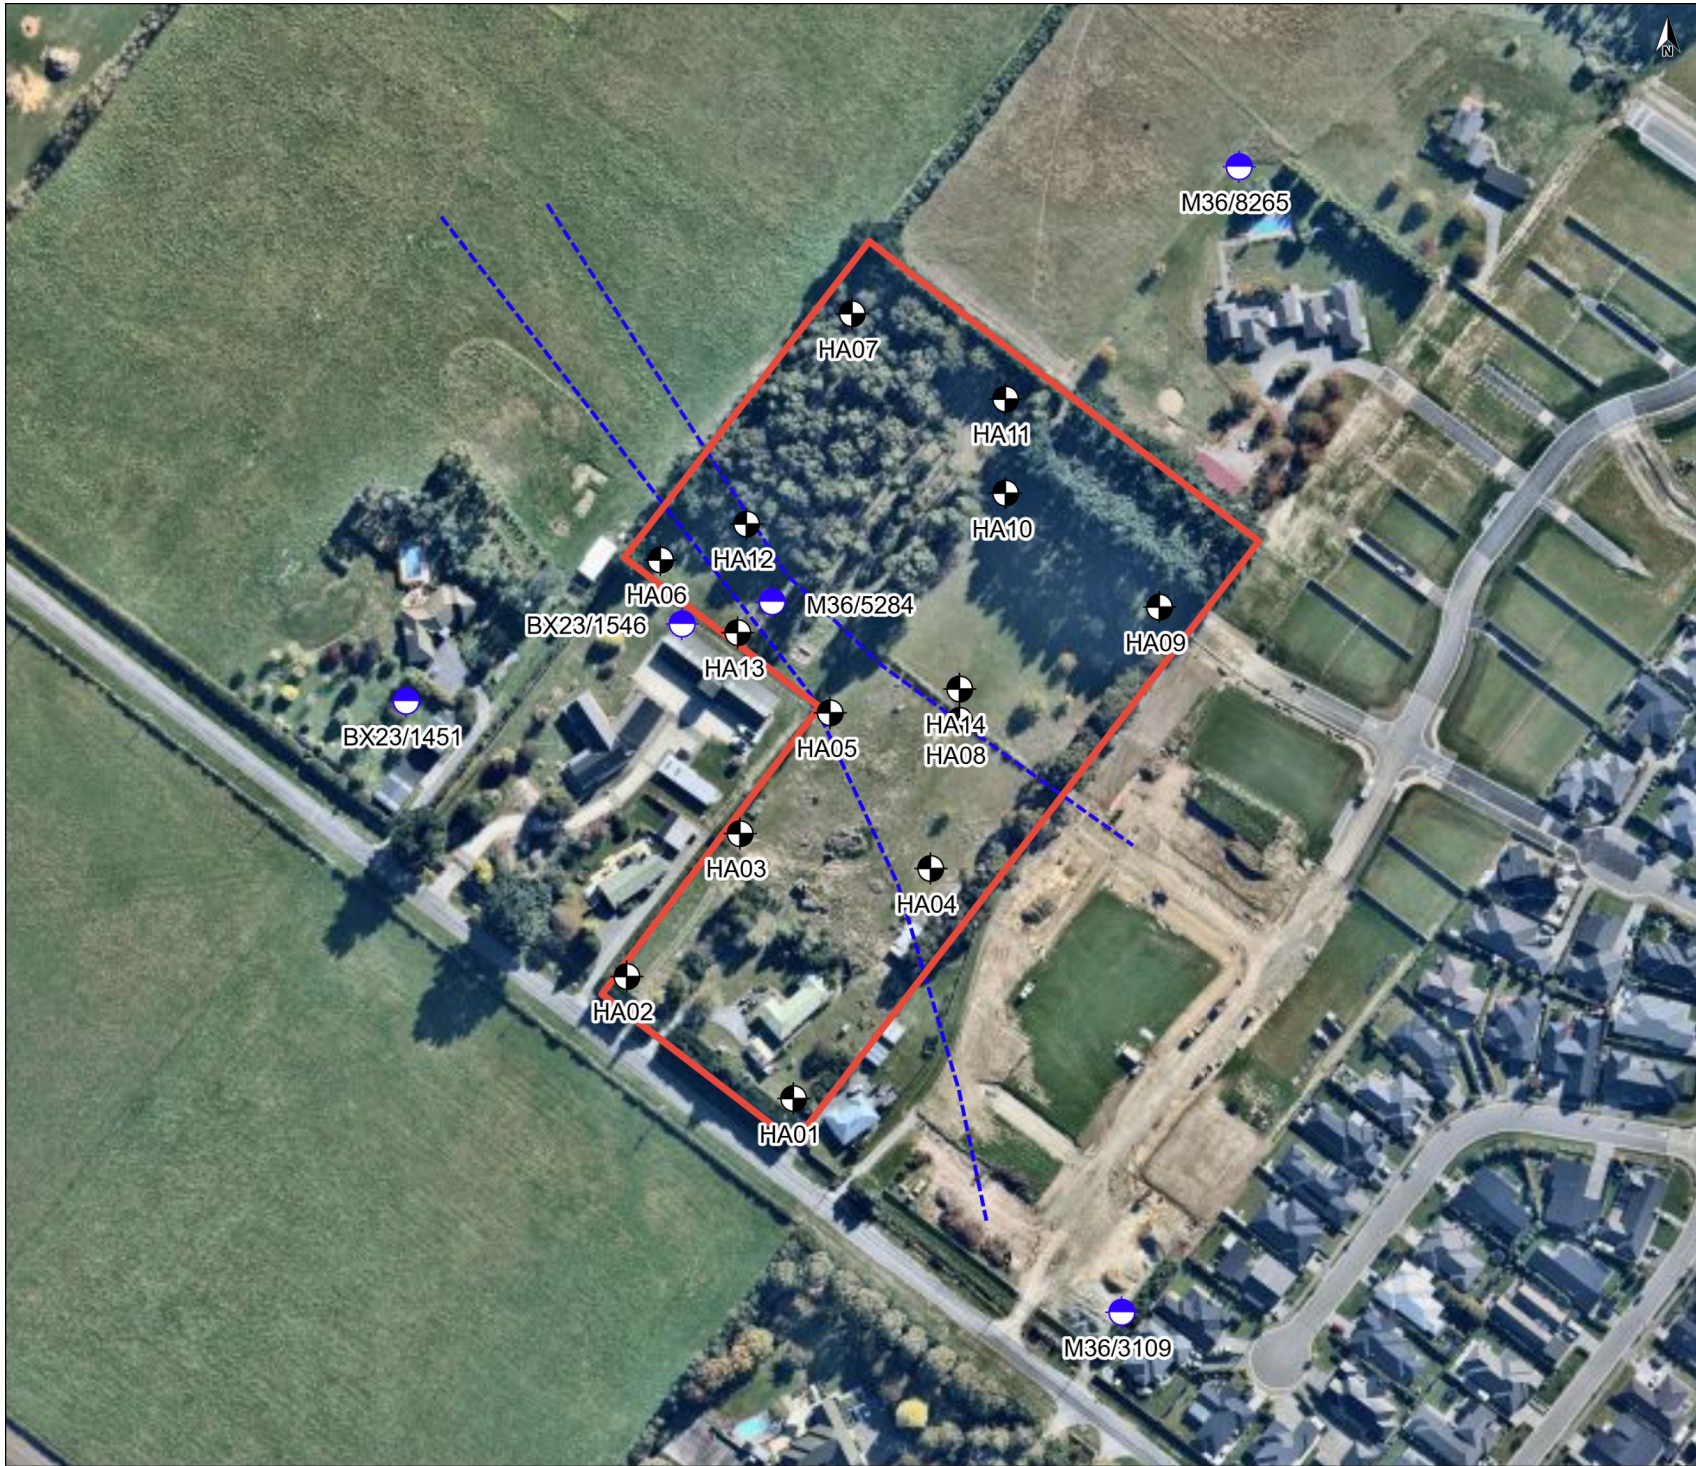
## **APPENDIX 1:** Geotechnical Investigation Plan

- Legend**
- ECan Wells
  - Hand Augers
  - Site Boundary
  - Inferred Paleochannels
