## Geotechnical Investigation

Rhodes Land

Trents Road

Prebbleton

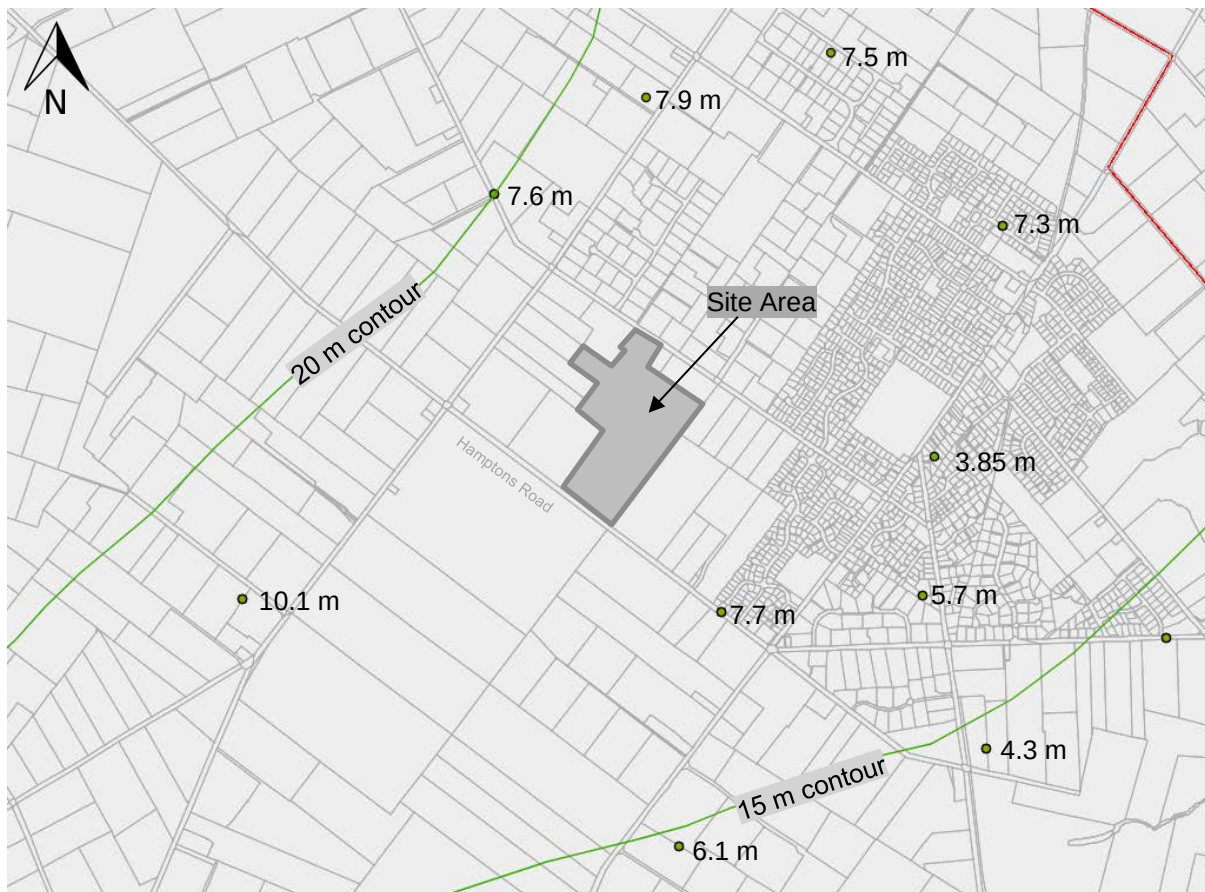
**Figure 4: ECan Regional Piezometric Elevation Contours and Piezometric Wells used in various published groundwater studies.**

We have reviewed the well information from ECan used in various published groundwater models and groundwater contour maps available on Canterbury Maps. Published regional mapping of groundwater shows the site is located approximately halfway between the 15 m and 20 m groundwater elevation contours. The site itself is located at an elevation of approximately 24 m to 27 m, which suggests the depth of the groundwater surface below the site is approximately 6 m to 9 m depth (Figure 4). Various other published groundwater studies available on Canterbury Maps show the site located between contour lines ranging from 5 m to 10 m (Figure 5), indicating the groundwater beneath the site is at least 5 m deep and may be up to 10 m deep. Nearby piezometric wells summarised on Canterbury Maps (shown in Figure 4) generally corroborate with mapped groundwater contours and with the groundwater information from wells described in Section 3.4.

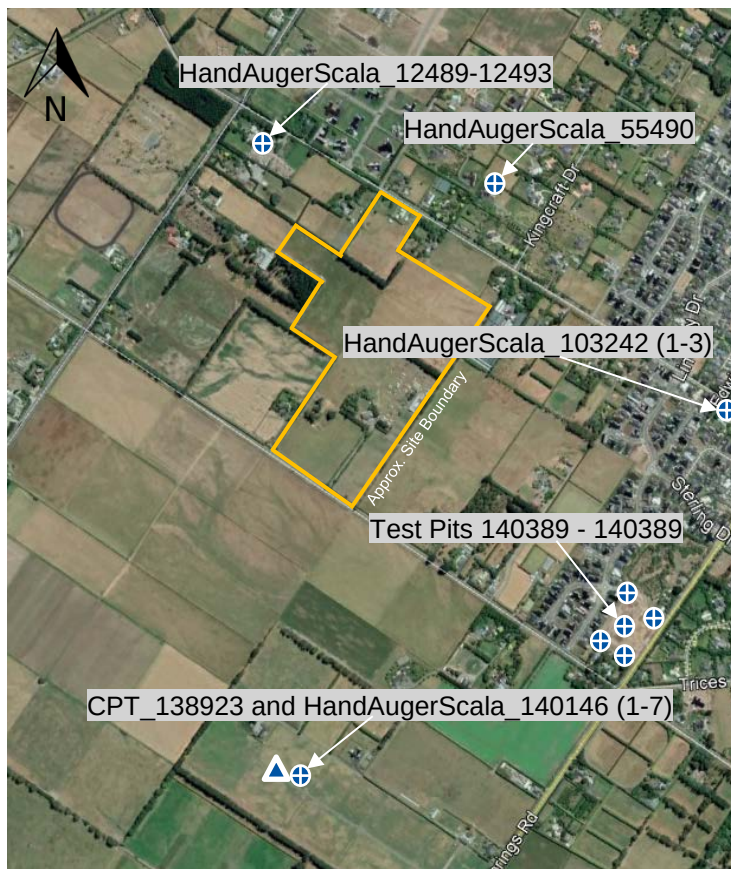
**Figure 6: Nearby Geotechnical Investigations**

We have reviewed the New Zealand Geotechnical Database subsurface data and have summarised the closest geotechnical data to this site in Table 2. Investigation locations are shown in Figure 6.

The ground conditions in nearby testing locations are generally consistent and comprise shallow sand and silt overlying gravel.

Testing within an area located 800 m south of the site shows a deeper profile of sand and silt overlying gravel – liquefaction was observed in this area following the 2010 Darfield Earthquake and the land has been categorized as TC3 (see Figures 2 and 3). The area of observed liquefaction appears to be constrained to a linear area that is likely related to a deeper channel of silts and sands. We do not consider this area represents the ground conditions beneath the site.
